# Bairnsdale Sporting Facilities Plan 2018

## Volume 2 – Sporting Facilities Condition Report

February 2017

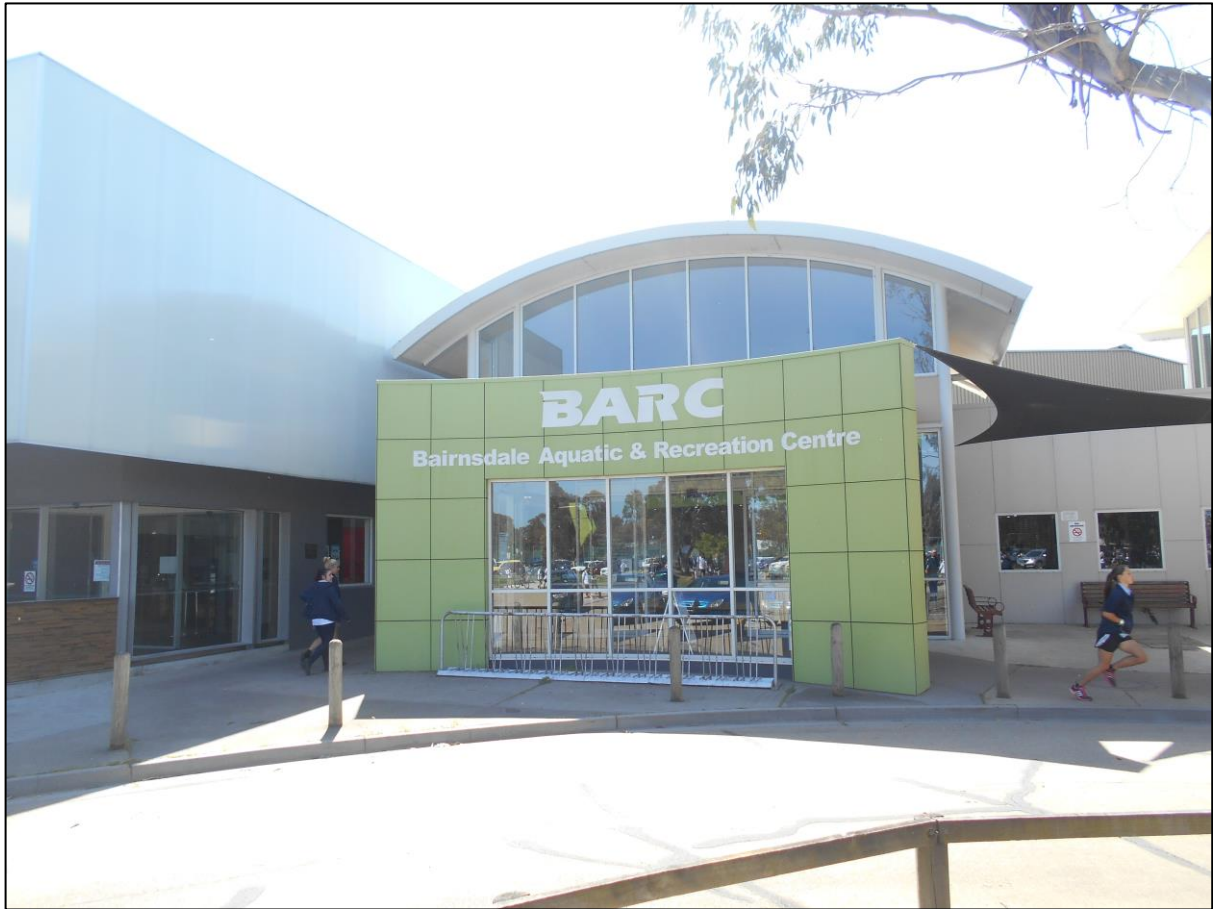
## 1.1 Bairnsdale Aquatic and Recreation Centre (BARC) - Stadium

The Centre is generally considered to be in good condition and has undergone a number of past extensions and refurbishments. The entry, foyer, and ancillary spaces are in relatively good condition and have been well maintained, however upgrades are proposed in order to address functional issues.

The focus of the facility condition inspection related to the stadium space, which is in fair to good condition:

- The existing timber flooring has been well maintained and is in good condition.
- High bay lighting has been recently upgraded to LED and is functional.

- The grandstand seating has been constructed using a combination of hardwood and pine timber cladding. The hardwood has been well maintained and is functional. Replacement of the pine cladding should be considered as it is aesthetically poor and is not very durable in this environment. A hardwood to match the stand seating should be considered.

- The existing scorers / announcers box construction and level of finish is average and should be upgraded.
- The exposed portal steel frame has been painted (light blue) and while in good condition, an alternative more contemporary finish should be considered.

Externally the building is in good condition, however the colourbond cladding requires cleaning and localised graffiti removal. The low height brick walls are in good condition, but rendering (for aesthetic purposes) should be considered if the structure is to be maintained and not extended to the north.

The Stadium is in good condition, however some finishes are dated and an upgrade should be undertaken in relation to mechanical services and insulation. Minor regulatory and DDA compliance upgrades are required, which could be addressed by Council as maintenance works.

Capital works to the stadium are primarily recommended to address user functional needs, which could be accommodated by extending the building to the north of the stadium (assuming the bus terminal is relocated) to provide additional compliant courts, and possibly a minor extension to the south for staff facilities.

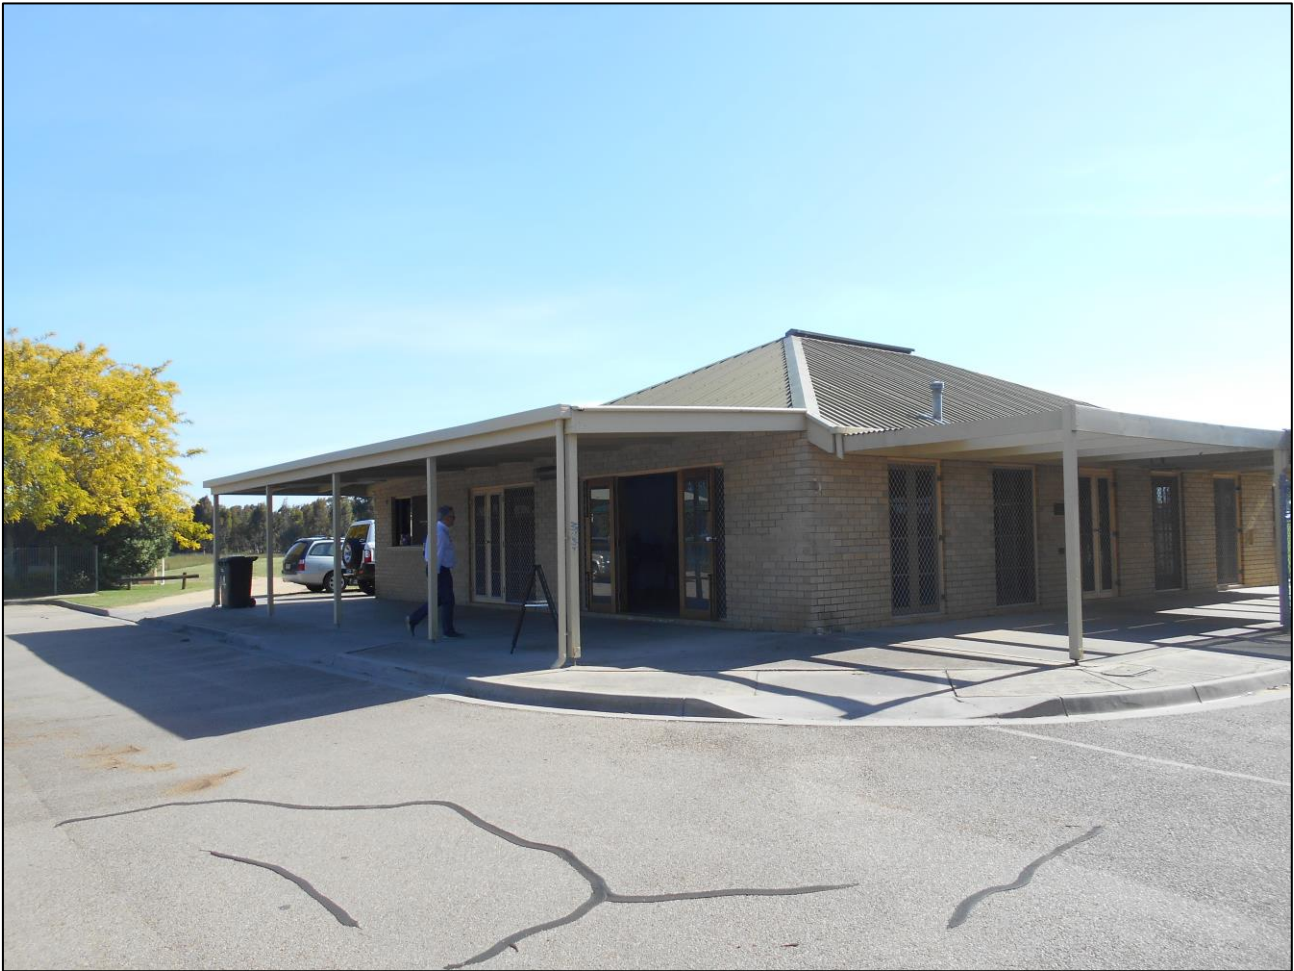
## 1.2 WORLD Netball Facilities

The existing facility is in fair to good condition, with the structural performance appearing to be satisfactory. A number of elements of the building are in poor condition, however the building has been relatively well maintained throughout its operational life.

- The roof requires repair (or replacement) as a number of roof leaks were observed.
- The timber fascias require localised repair and repainting.
- The eaves gutters require cleaning, as they are currently blocked.
- The external finish of the building is functional (exposed brick) but dated and requires an aesthetic upgrade.
- The external / security lighting is dilapidated and requires full replacement.
- The hot water service has failed – currently no hot water is available to the pavilion.

Internally the facility has been well maintained, however both the finishes and fixtures are in poor condition and require replacement, in particular the kitchen joinery and appliances. The social space requires new lighting and carpet replacement. The player's amenities are in good condition, however the finishes are very dated and should be upgraded along with the fixtures. The internal blockwork should ideally be lined with plasterboard or tiled in order to visually improve the space for users.

- There is a considerable step at the main entry to the building ground slab – no ramping has been provided.
- The existing accessible toilet is undersized and does not meet current DDA code requirements. All fixtures are non-compliant and require replacement to meet code requirements.
- No ambulant toilet facilities have been provided (a minimum of 1 per bank of toilets is required).
- No statutory (braille) signage has been provided.
- The existing main entry doors, sliding door to the amenities airlock and accessible toilet doors do not achieve a sufficient clear opening and have a lack of circulation (latch side) clearance.
- The car park accessible car bay does not comply with current standards – an adjacent shared / circulation bay is required and the bay is oversized.

- The female change room and female amenities have a sufficient number of toilets and showers to accommodate netball or hockey teams (minimum of 2 showers and 2 pans required per team), however only 1 change room has been provided which presents a functional issue when concurrent games are being played.
- The male change room is undersized by approximately 10m<sup>2</sup> for netball and hockey use.
- The number of male pans and showers (1 each) is inadequate.

The facility is in fair to good condition and requires minor upgrades/refurbishment to address the condition and compliance issues noted above. A number of these could be undertaken as maintenance works in order to achieve building code compliance. The facility would require an extension (possibly to the south and west) to address the functional issues identified.

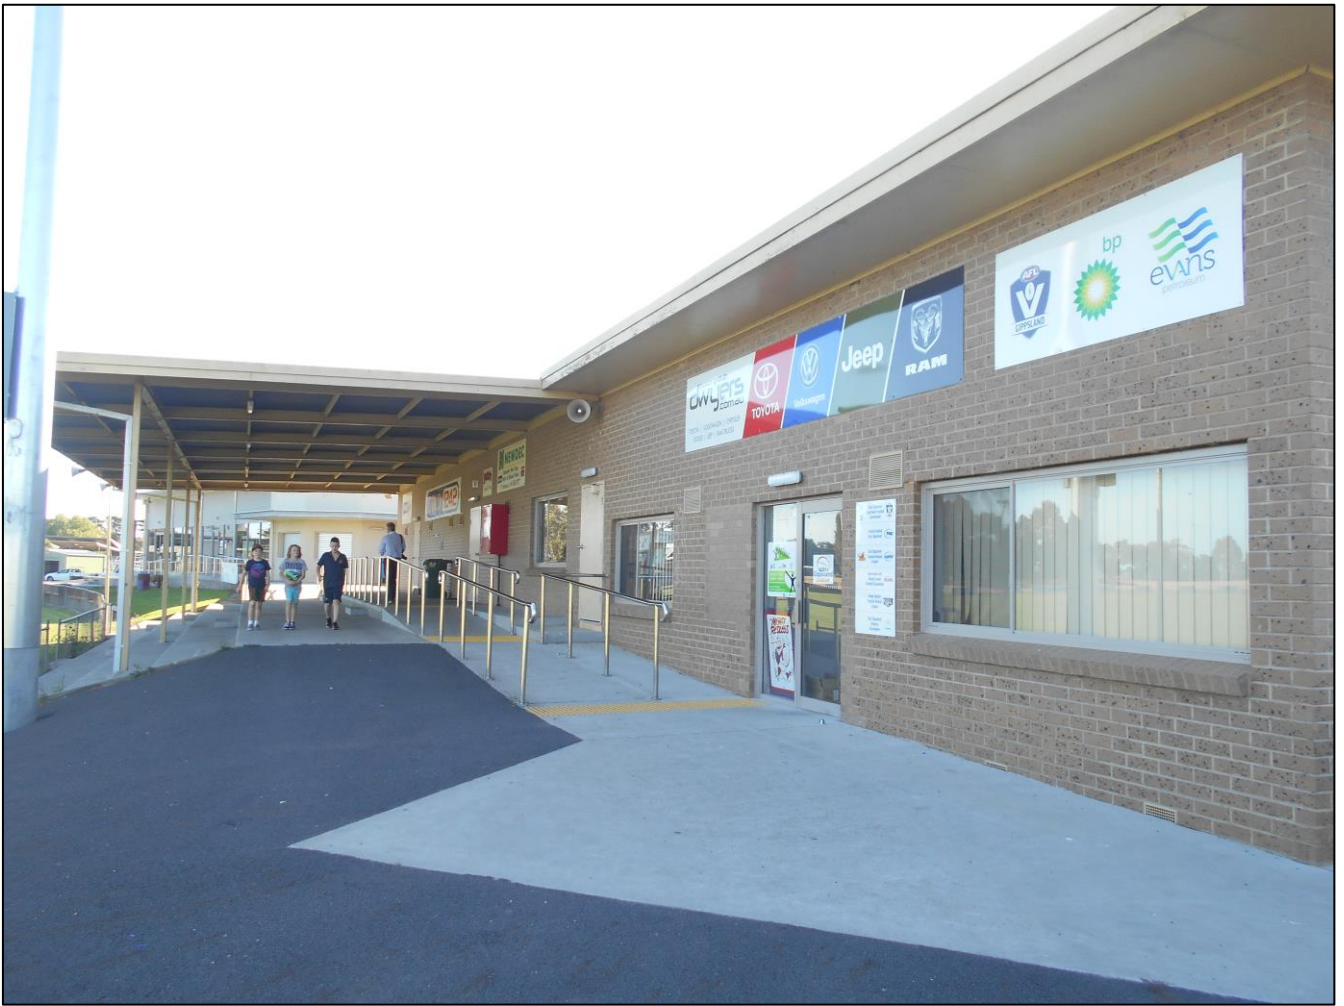
### 1.3 Bairnsdale City Oval Sports Pavilions

The social room building was redeveloped and extended in 2007 and is in very good condition and has been well maintained. The social space is relatively large (250m<sup>2</sup>) and is served by a fully commercial kitchen, which includes appropriate stainless steel bench and appliances. The social room amenities are in good condition and would adequately cater for the space based on building code requirements.

- The social / function room broadloom carpet is in fair condition – replacement with carpet tiles is recommended in the future.
- The external render to the brickwork requires repair in a number of locations.

The sports pavilion building was refurbished in 2007 and is generally in relatively good condition structurally, with some localised movement apparent in the external. While the finishes were upgraded in recent years, some are in fair condition and require review.

- The general external condition of the building is good, however the existing spectator structure steel framing is corroding – steel members would likely require a combination of localised repair and replacement. A soffit lining to the structure may also be considered for aesthetics and to protect the frame from exposure to moisture.

- A number of external concrete block walls are showing signs of localised movement / are cracked in the change rooms and require further inspection (to confirm extent of structural movement) and repair.

- The broadloom carpet in the change rooms is in poor condition and should be replaced.
- The plasterboard ceilings in the change rooms are damaged, showing extensive signs of mould and have locally dropped on the southern side (possibly due to roof leaks and or movement in the external block walls). Rectification is required.

- The first aid / trainer's concrete slab floor has been painted and has worn / delaminated. A vinyl floor finish should be considered.
- The amenities generally require maintenance and repair – fixtures have been damaged or are missing (shower heads), the vanities are poorly fixed to block walls and general cleaning is required.

- The existing accessible toilet in the social room building has been constructed to the previous 2001 Australian Standard and is undersized. It is likely that a dispensation could be provided should any works be undertaken, however an upgrade to meet current standard size requirements is recommended.

The facilities are in relatively good condition, however the sports pavilion building has a number of important maintenance issues and functional deficiencies, in particular the lack of unisex player's and umpires amenities. An upgrade of the interior finishes and the player's amenities and umpires facilities are therefore recommended as medium level upgrade works.

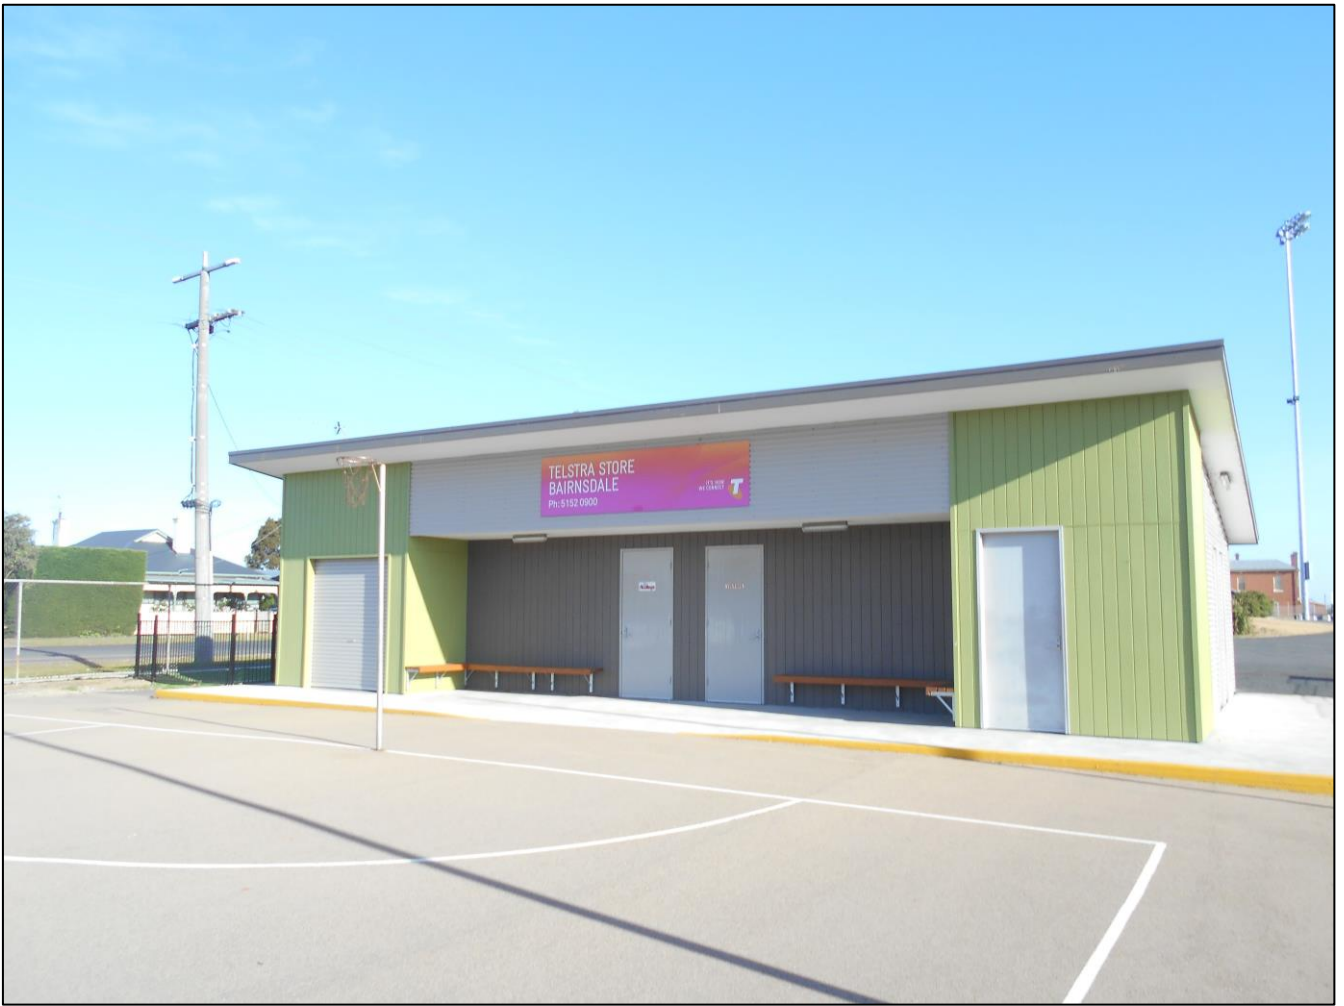
## 1.4 Bairnsdale City Oval Netball Pavilion

The facility was recently constructed in 2015/16 and is in very good condition both internally and externally. The level of finish internally has been well maintained and is fit for purpose.

The only minor issue noted relates to the cleaning of the external soffits and eaves, particularly around the security lighting due to the presence of insects. Additional cleaning is recommended as part of the facility maintenance program.

It was observed that the change rooms and medical / first aid room are currently being used for Club property storage purposes. A post-occupancy assessment of Club storage requirements should be undertaken to confirm whether the new facility meets Club storage needs.

The facility has been very recently constructed and is in very good condition and is generally fit for purpose. No capital works are recommended for the facility.

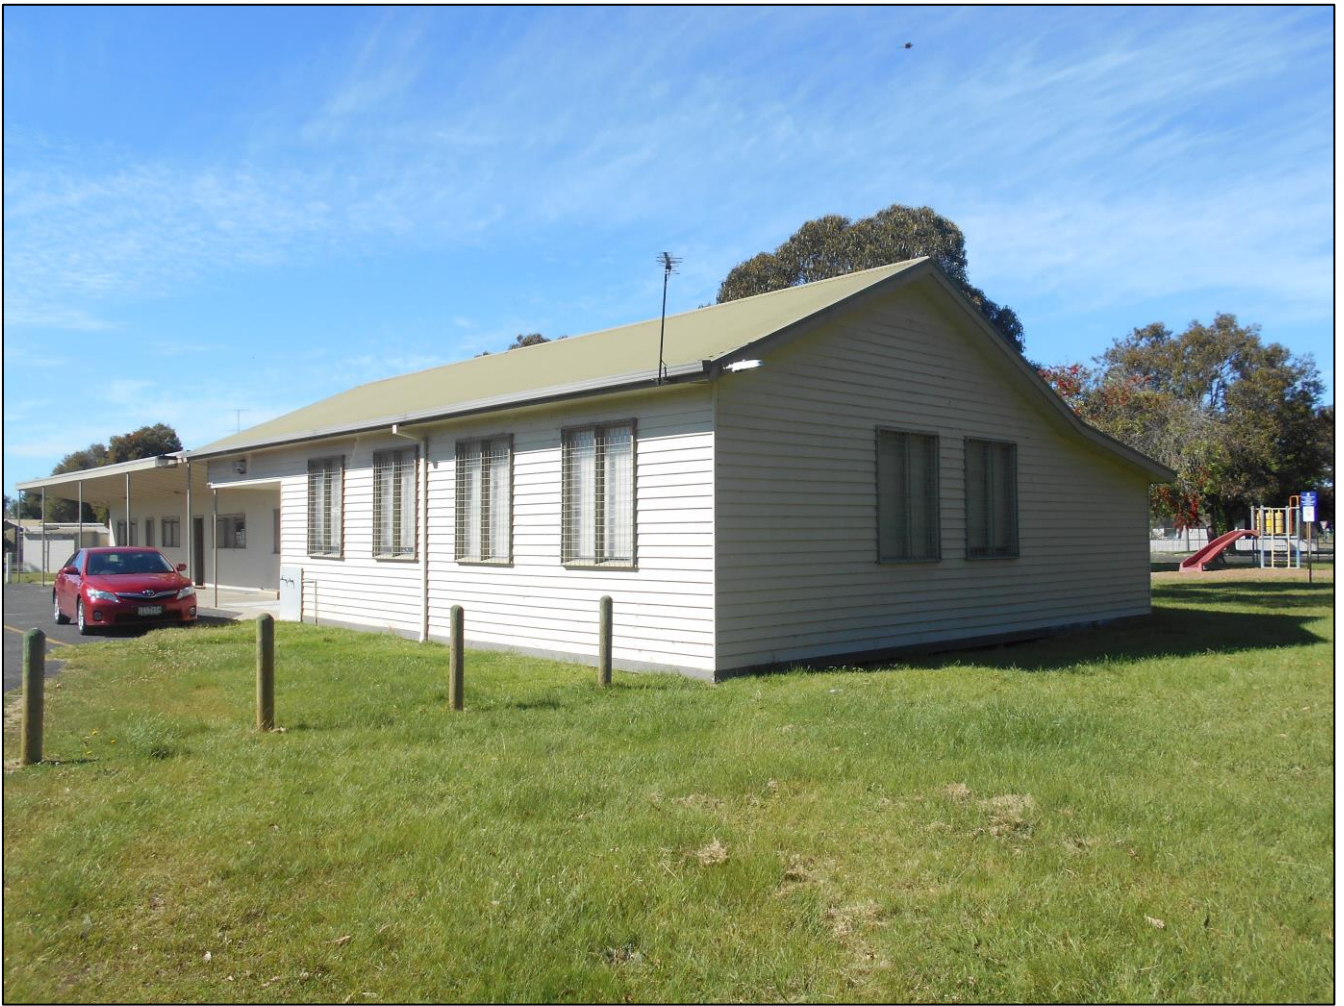
## 1.5 West Bairnsdale Oval Pavilion

The building is currently more than 60 years old and has been constructed domestically and while very dated, appears to have been very well maintained by the Committee of Management and Council. The exterior of the building (cladding and roof) appear to be in good to fair condition and have been painted/repared throughout the life of the building. The eaves gutters and downpipes also appear to have been replaced in recent years. Some maintenance is required to the exterior weatherboard and painting to rear doors and frames.

- The player's change rooms are dated (particularly the external wall finishes which are poor), however they are clean and have been well maintained.
- The player's amenities are in poor condition and are not functional. A number of finishes are dilapidated and require repair – the fixtures are also very old and unsightly. Interim solutions are recommended while the longer term plan for the facility is determined.

- The accessible toilet facility has been recently upgraded and is both compliant and in good condition.
- The public amenities are clean and in relatively good condition, however are very dated (in particular the floor tiling and pine wall / partition treatments) and require refurbishment / possible replacement.

- The social room has been very well maintained, but finishes are dated. The floor and ceiling grid are in relatively good condition. The lighting should ideally be replaced.

- Player's amenities are inadequate – 3 pans and 3 showers per team are required.
- Players amenities have not been constructed to unisex standards.
- There are no umpires facilities.
- There is no medical / first aid room.
- There is no space for massaging or strapping purposes.

While the facility has been well maintained, it is reaching the end of its asset life and a number of significant functional and compliance issues exist. These aspects could be addressed through a combination of internal refurbishment works and extending the player's amenities to meet code/unisex requirements along with new umpires facilities. However, there would be limited value in undertaking such significant refurbishment works to a building of this age and domestic construction standards. Redevelopment / renewal of the facility this therefore recommended. It would be possible to undertake minor works to the existing player's amenities and conversion of the store room to the south of change room 1 into player's amenities in order to provide an interim solution while a new facility is planned and capital funding is sought.

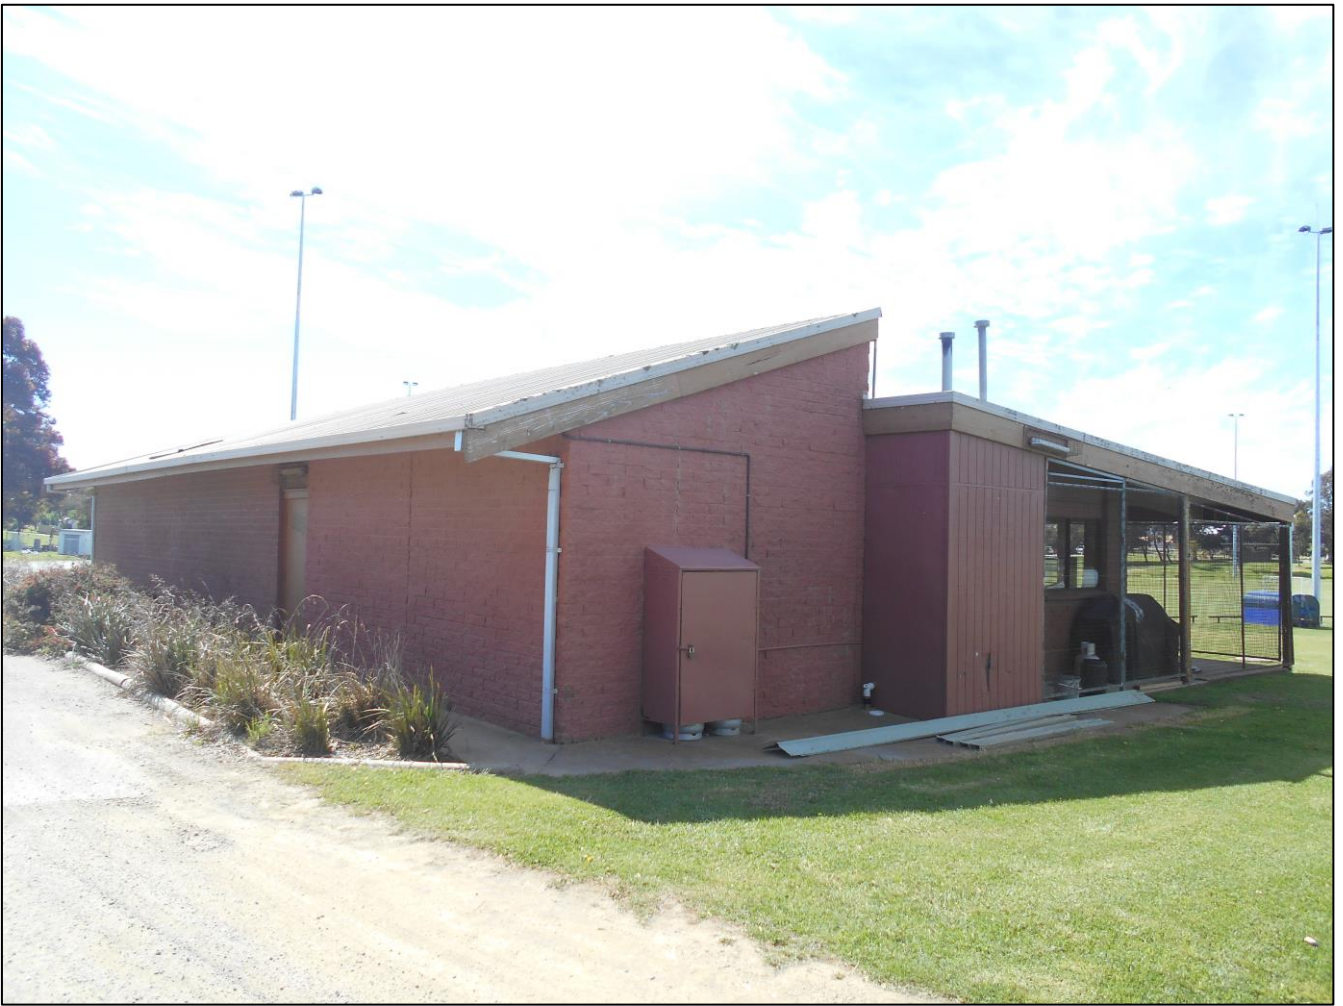
## 1.6 Howitt Park – Roderick Pavilion

The building is approximately 30 – 35 years old and has been relatively well maintained by both the Committee of Management and Council. The building appears to be performing well structurally, with no major signs of movement or instability. Externally the building façade and roof are in fair to good condition, however maintenance is required with respect to a number of items:

- The fascias require repair / replacement and painting.
- The timber cladding to the west elevation is damaged and requires repair.
- The external security lighting should be upgraded / replaced.
- The roof requires extensive cleaning to remove lichen.
- The external doors require re-painting / removal of graffiti.
- Repair of the concrete slab at the main entry sliding door is required.

- The female amenities are in relatively good condition but are not functional (see below). The finishes are dated (particularly tiling) and require a refresh / upgrade.
- The male amenities are similar to the female amenities and are clean but dated in aesthetic. Functional issues also exist in relation to the communal showers.
- The social room is in good condition and has been well maintained. However the lighting should be upgraded and the broadloom carpet replaced.
- The kitchen is clean/well maintained, however the joinery and fixtures are of domestic grade and are likely not fit for purpose.

- The existing male amenities have not been constructed to unisex standards – an open / communal shower and trough urinal are present. Mirrors and hand dryers are also not provided in the amenities.
- The player's change space consists of a single bench combined with the shower area, which is insufficient in size for soccer use and would not meet FFV recommendations.

The facility is generally in good condition but is recommended to be upgraded/ refurbished to address the functional and compliance issues noted above, particularly with respect to the player's / umpires amenities and provision of an accessible toilet facility. The facility would require both an internal refurbishment and an extension (to the east or west) to achieve these requirements.

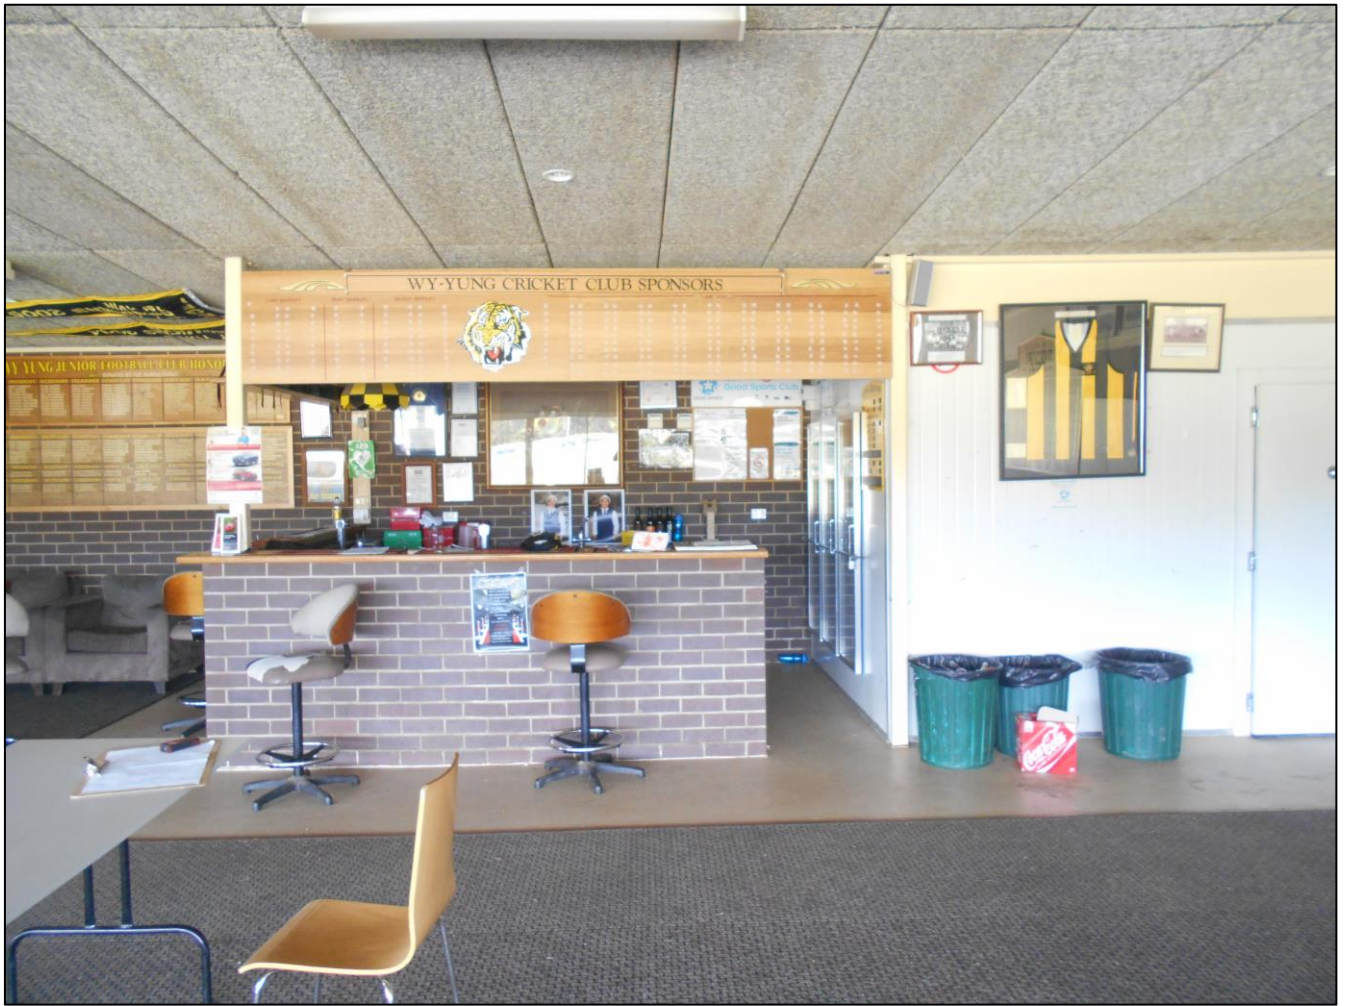
## 1.7 Wy Yung Recreation Reserve Pavilion

The original pavilion building is approximately 40 years old and has been relatively well maintained, but is in fair condition (particularly the amenities). The social room is approximately 30 years old and is both clean and well maintained. Both areas appear to be in satisfactory structural condition with no major signs of movement or instability. A key issue associated with this site / building is the proximity to the Mitchell River and the associated risk of flooding / inundation, which has resulted in the building being almost fully submerged in recent years (2012). Timber frames and finishes were extensively replaced following this event.

The interior of the building is clean and in generally good condition particularly in the social room, however this is partially due to the refurbishment following the 2012 flood. Conditions in the change rooms and public / players amenities are fair to poor in some areas:

- The public female amenities are in relatively good condition, however the finishes are dated (particularly tiling) and require a refresh / upgrade.
- The change rooms are in good condition, however the ceiling is damaged in numerous areas and requires refinishing.
- The player's amenities are in fair condition and require interim repair to the wall linings, finishes and fixtures which are old and are unsightly. The player's amenities could be upgraded and extended in order to resolve the functional issues noted below.
- The social room is in good condition and has been well maintained. However, the lighting should be upgraded and the broadloom carpet requires localised replacement in some areas.
- The kitchen is clean/well maintained, however the joinery and fixtures are of domestic grade.

- Both the home and away teams currently share amenities, presenting a significant functional issue.
- The existing player's amenities have not been constructed to unisex standards – an open / communal shower and trough urinal is present.
- There is currently only 1 toilet pan for use by all players, which is a considerable deficiency.

The pavilion is generally in good to fair condition, however there are a number of functional and compliance issues as noted above, particularly with respect to the player's and public amenities and provision of an accessible toilet facility. The pavilion has the capacity to be extended and refurbished to achieve these requirements, however further review of the building siting and the risk of flooding is required. Discussions with Council and the East Gippsland Catchment Management Authority should be undertaken prior to proposing any significant facility refurbishment works.

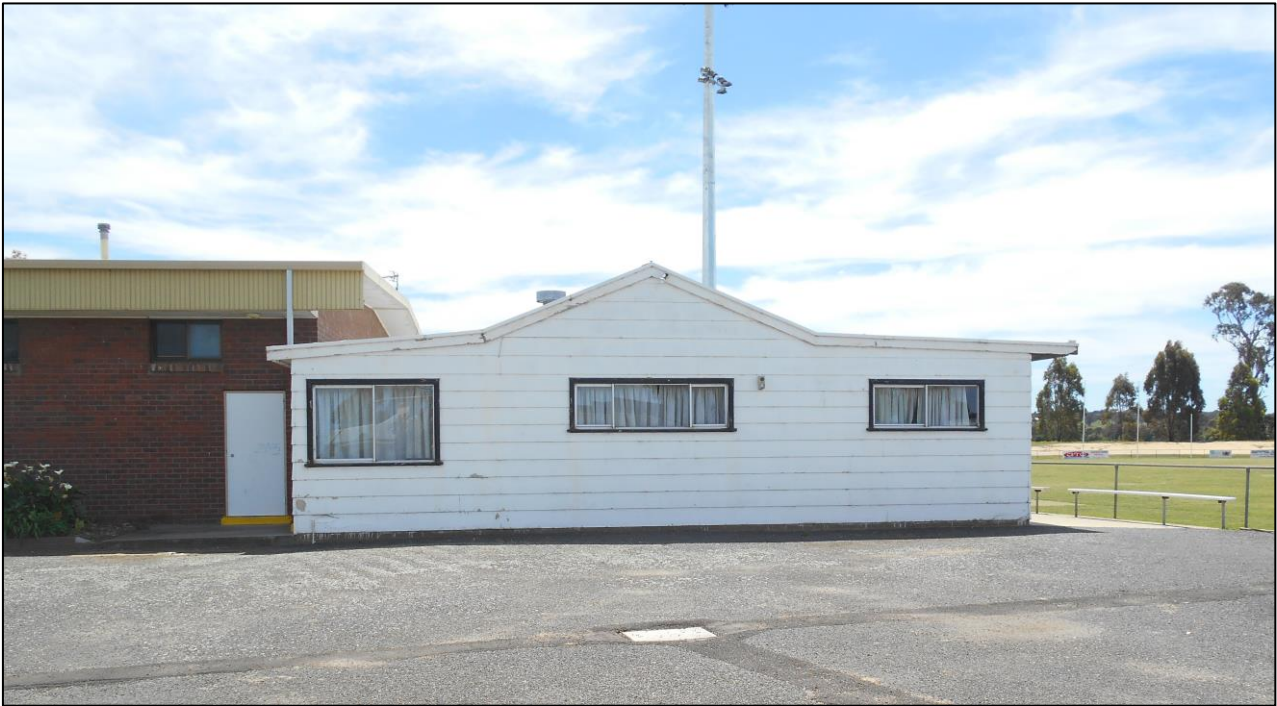
## 1.8 Lucknow Recreation Reserve Change Room and Social Room

The change room building is approximately 50 years old and is in poor condition externally and internally. Externally the timber weatherboard cladding and timber fascias are showing extensive signs of rot and weather damage. The external spectating area verandah framing is also in fair condition and finishes are deteriorating.

The condition of the interior varies, with the home change room being clean and well maintained, however the finishes are dated. The away change rooms are in moderate condition, but are undersized.

The existing kiosk condition is very poor, dated and not fit for purpose.

The change room building is rated a category 4 and is in very poor condition and has a number of functional issues. Retention and refurbishment of the building is not considered to be practical given the age of the building and the associated extent of works that would be required to bring the facilities up to an acceptable standard. The building location creates a barrier between the Social room and the oval, which is also not ideal from a functional and user perspective of social room users. Demolition of the change room building is therefore recommended. Siting for new facilities should be considered with the aim of providing a view and spectating to the oval from the Social room.
