**Bairnsdale Composting Facility**

# **Environmental Management Plan**

Prepared for: East Gippsland Shire Council 17 January 2025

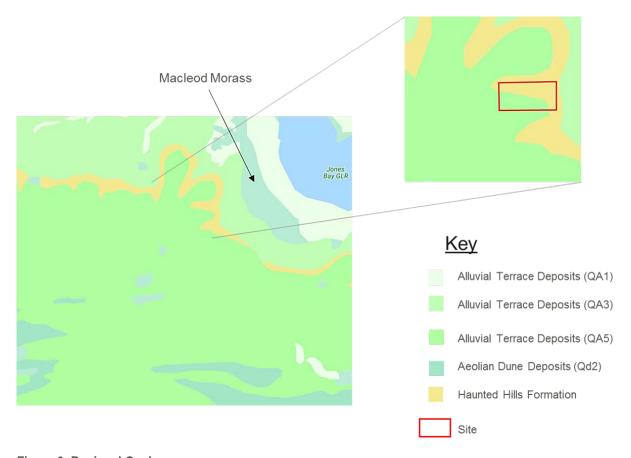
Figure 6: Regional Geology

The site is located within the Gippsland Basin on the Lakes Entrance Platform, north of the Lake Wellington Fault system. Surface and subsurface geology on the platform exhibits layers of Latrobe, Seaspray, and Sale Group sediments. The regional geology surrounding the site is presented on the 1:250,000 Geological Survey Map (1:250,000 Bairnsdale sheet) and shown on Figure 6.

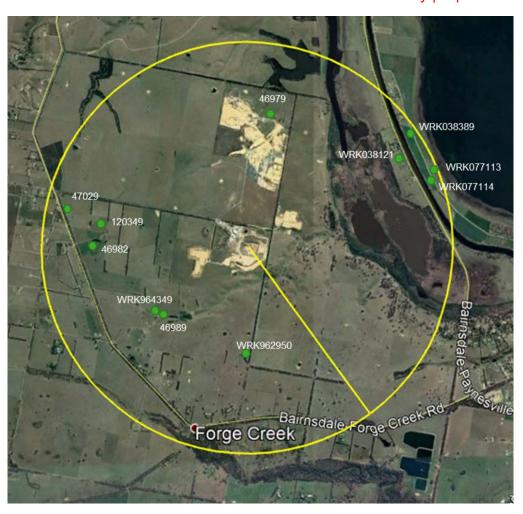
Figure 27: Licensed Groundwater Abstraction within 2 km of the Site

A search of the Water Management Information System (WMIS) identified 11 bores listed within a 2 km radius of the site licensed for groundwater extraction. Details are provided in Table 11 and the locations are shown on Figure 27.

Based on the information available abstracted groundwater use is limited within the immediate area of the site. The closest registered groundwater well for consumptive use (domestic and stock) is bore WRK038121 located approximately 1.9 km to the northeast of the site. Bore WRK038121 is located on the distant (eastern) side of the Morass to the site making it unlikely that groundwater from the site would be extracted from this bore. Downgradient of the site there are no existing wells registered between the site and the Morass.

Agriculture, Parks and Gardens - this groundwater use was not indicated for wells within 2 km of the site (Figure 27) and given the land use and proximity of the Morass is not likely to be realised down gradient of the site. Agriculture, Parks and Gardens is therefore not considered to be precluded by contamination of groundwater.

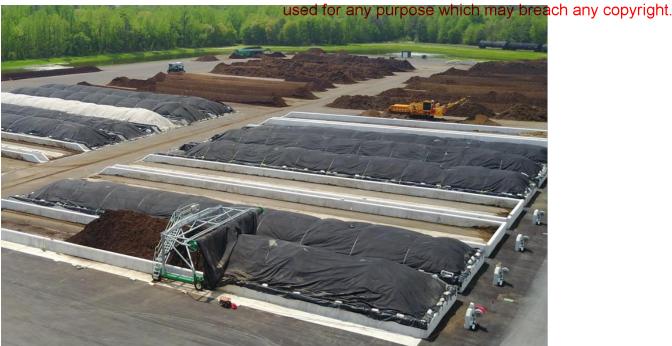
Figure 2: Example of an enclosed aerated composting system

- 1- Enclosed receival- All feedstock received on site will be initially deposited in an enclosed receivals area to reduce odour emissions from the receival process.
- 2- Enclosed aerobic composting- the initial pasteurization stage of the composting process will take place in an enclosed aerobic composting system (see figure 2). This type of system significantly reduces odour emission from the organic waste during the first stage of composting.

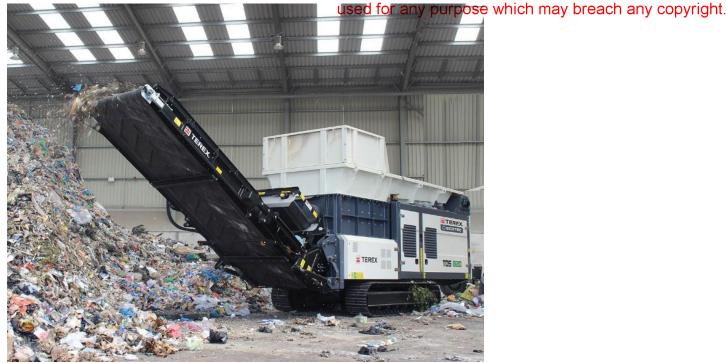
Figure 6: Example of Slow Speed Grinder (Source: Terex)

The nature of organic waste accepted on site consisting of waste from small organic particles through to large tree stumps creates a requirement for the grinding of waste prior to composting. Council currently engages a contractor for the periodic grinding of organic waste however this facility would require daily grinding to continuously feed the composting process and avoid stockpiling of waste. As such a suitable slow speed grinder will be required. Figure 6 provides an example of the type of slow speed grinder which would be required.

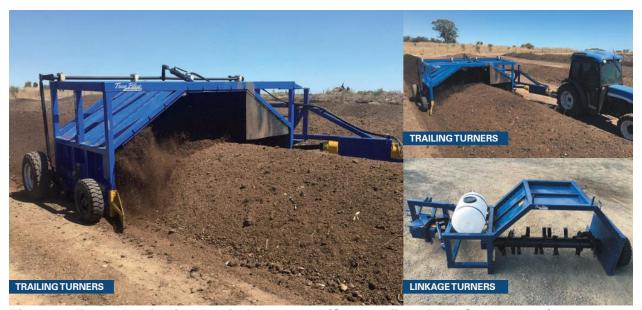
Figure 8: Example of suitable windrow turner (Source: True Blue Composters)

The turning of open windrows requires a specialized windrow turner. Available technology in this space ranges significantly in scale and cost. An assessment of plant used at similar sized facilities indicates that a suitable turner would be one similar to that shown in Figure 8. The windrow turning unit requires a tractor to tow and provide power to the unit. The windrow turning unit will also include an inbuilt water tank and spray manifold to apply water to the windrows as required.

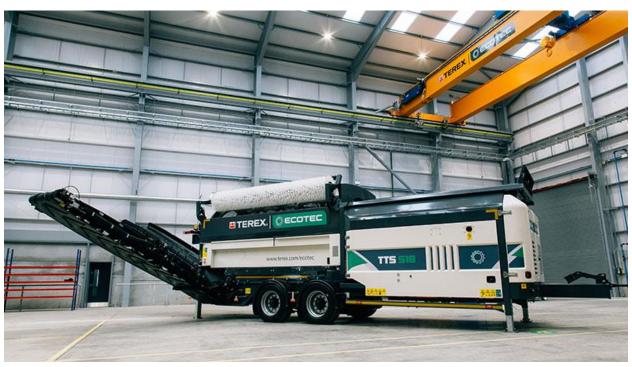
Figure 9: Example of suitable Trommel (Source: Terex)

The variable nature of organic waste feedstock means that the finished compost contains a variety of material sizes. In line with Australian Standard 4544: Composts, soils conditioners and mulches, a mature composted soil conditioner is to contain particles no larger than 16mm. As such the Trommel will require a 16mm screen to separate all material larger than 16mm. Figure 8 below provides an example of a suitable trommel for the facility.
