NOTICE OF AN APPLICATION FOR PLANNING PERMIT

The land affected by the application is located at:	80 Old Orbost Road SWAN REACH VIC 3903 Lot: 2 PS: 600917
The application is for a permit to:	Two Lot Subdivision and Removal of Vegetation
A permit is required under the following clauses of the planning scheme:	
Planning Scheme Clause	Matter for which a permit is required
32.05-5 (TZ)	Subdivide land
42.02-2 (VPO)	Remove, destroy or lop vegetation
The applicant for the permit is:	Development Solutions Victoria Pty Ltd
The application reference number is:	5.2026.105.1

1. INTRODUCTION

Tree Summary Report

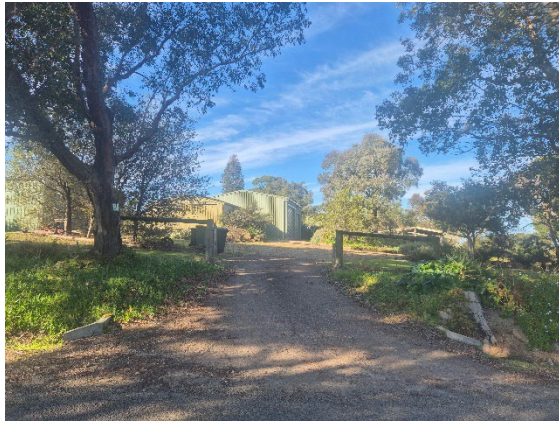
Photograph 2 – Existing access to proposed Lot 1 at 80 Old Orbost Road, Swan Reach.

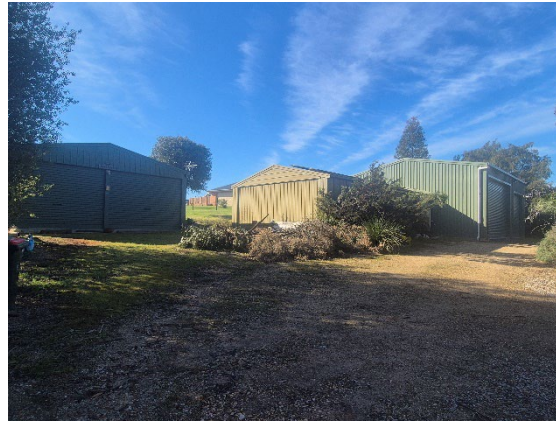
Photograph 4 – Existing outbuildings on proposed Lot 1, facing east.

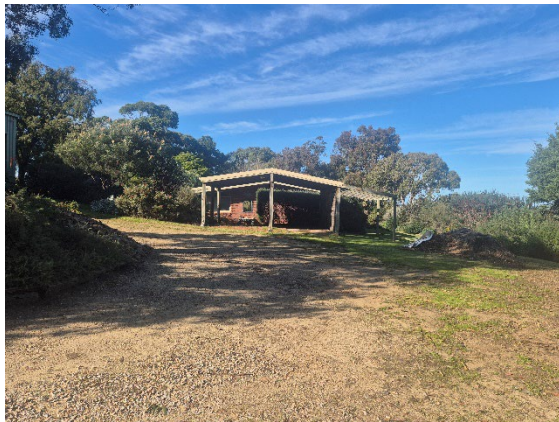
Photograph 3 – Existing dwelling on proposed Lot 1, facing south.

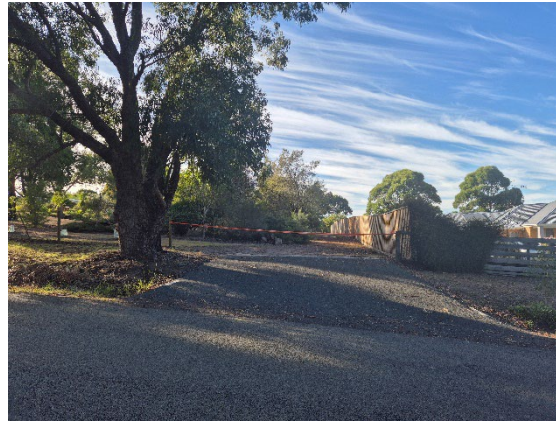
Photograph 10 – Existing crossover to proposed Lot 2 on the northern boundary, facing south.

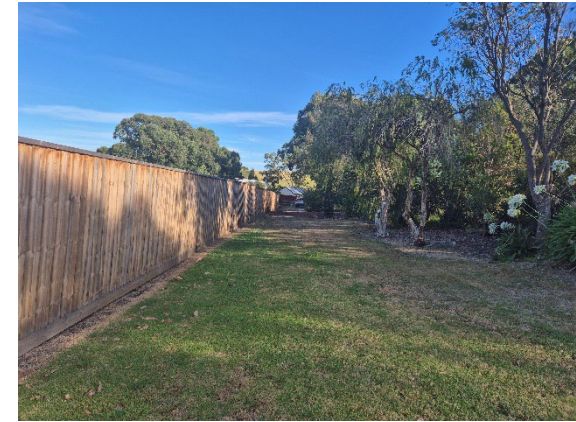
Photograph 12 – Western boundary in the northern portion of the of subject site, showing proposed access to Lot 2, facing north.

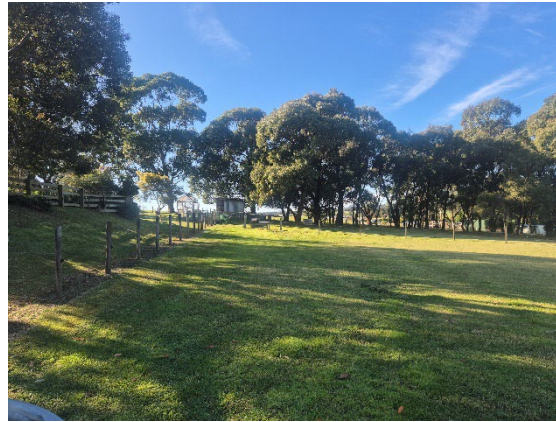
Photograph 16 – Access to proposed Lot 2 facing east.

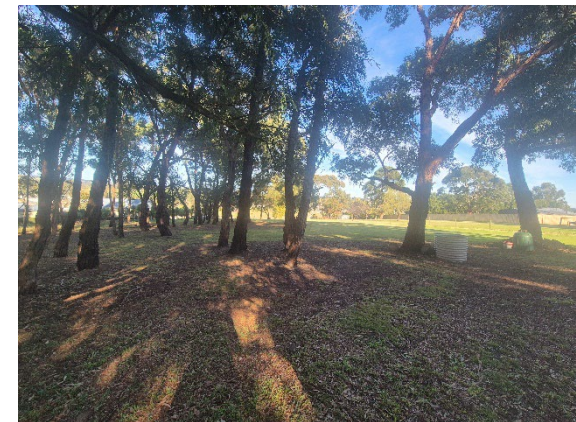
Photograph 19 – Vegetation on the eastern portion of proposed Lot 2, facing south.

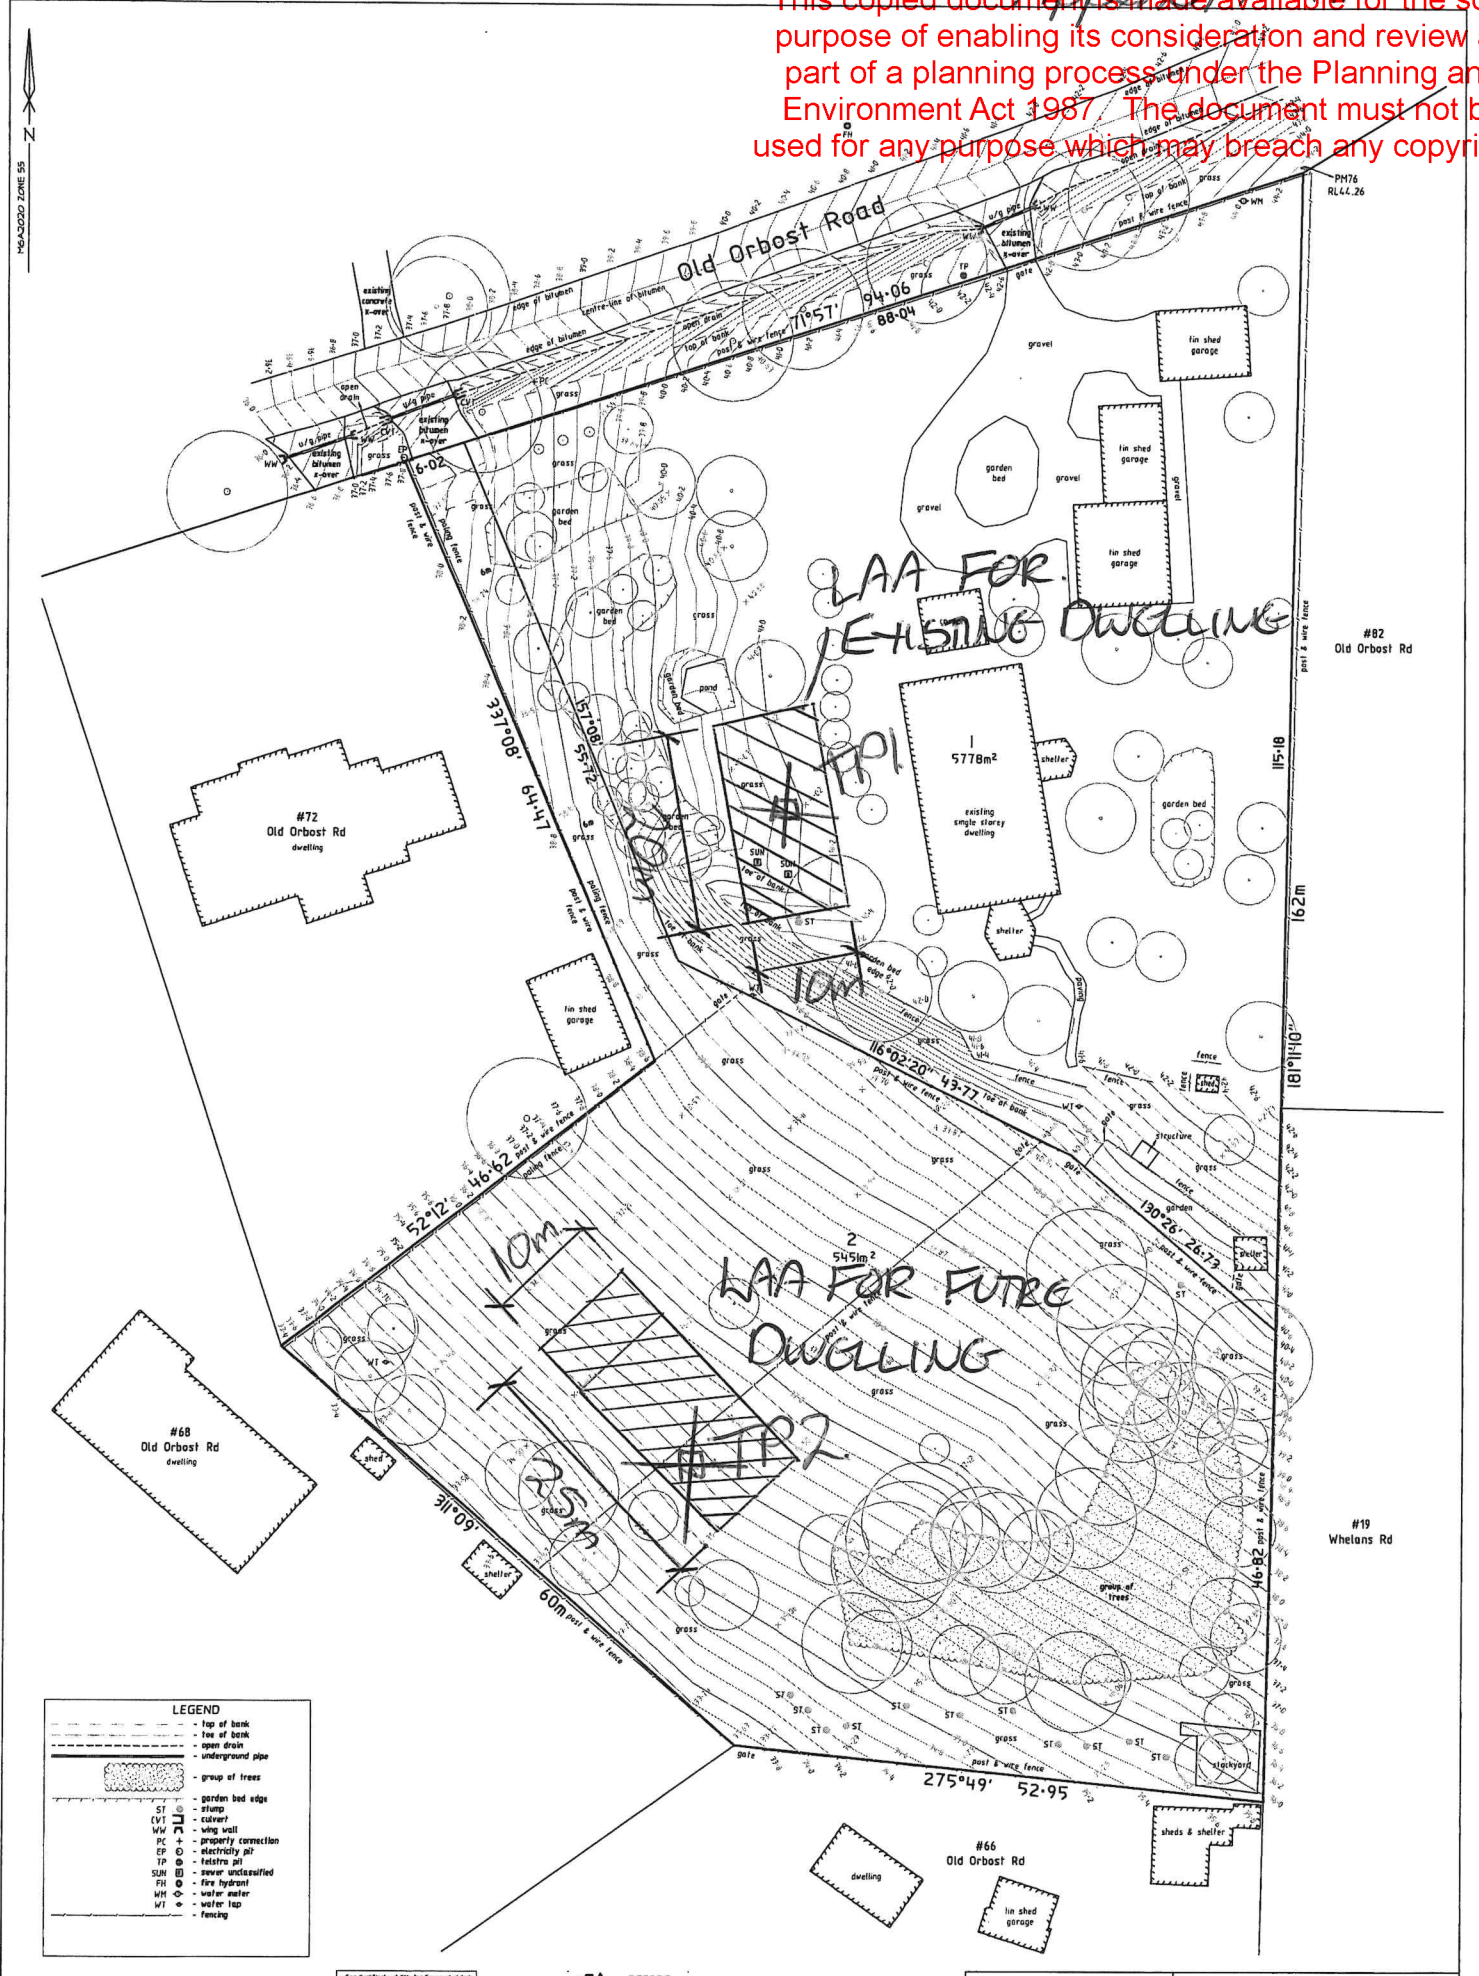
Sheet 1 of 1
 P:1300 853 157
 H:4549 543 757
 sks@oneplangroup.com.au
 www.oneplangroup.com.au
 GIPPSLAND - MELBOURNE

The purpose of this particular land capability assessment (LCA) is to investigate an area for a "Land Application Area" (LAA) on the proposed allotment and to investigate the location of the existing LAA serving the existing dwelling to determine whether relocation is needed and select suitable replacement area. The areas where the LAA's can be located is shown on our site plan Appendix 1, attached hereunder.

An area to the west of the existing dwelling was chosen for the relocation of the LAA for the existing dwelling with an area close to the south boundary selected for the proposed lot 2. All setbacks are required are easily achieved. Falls in the selected LAA's are in the range of 1 to 10%. The buffer zones are clear of any ephemeral waters. The area allocated for disposal field will not cause any detriment to the environment nor stormwater run-off quality within the precinct where the allotment is located.

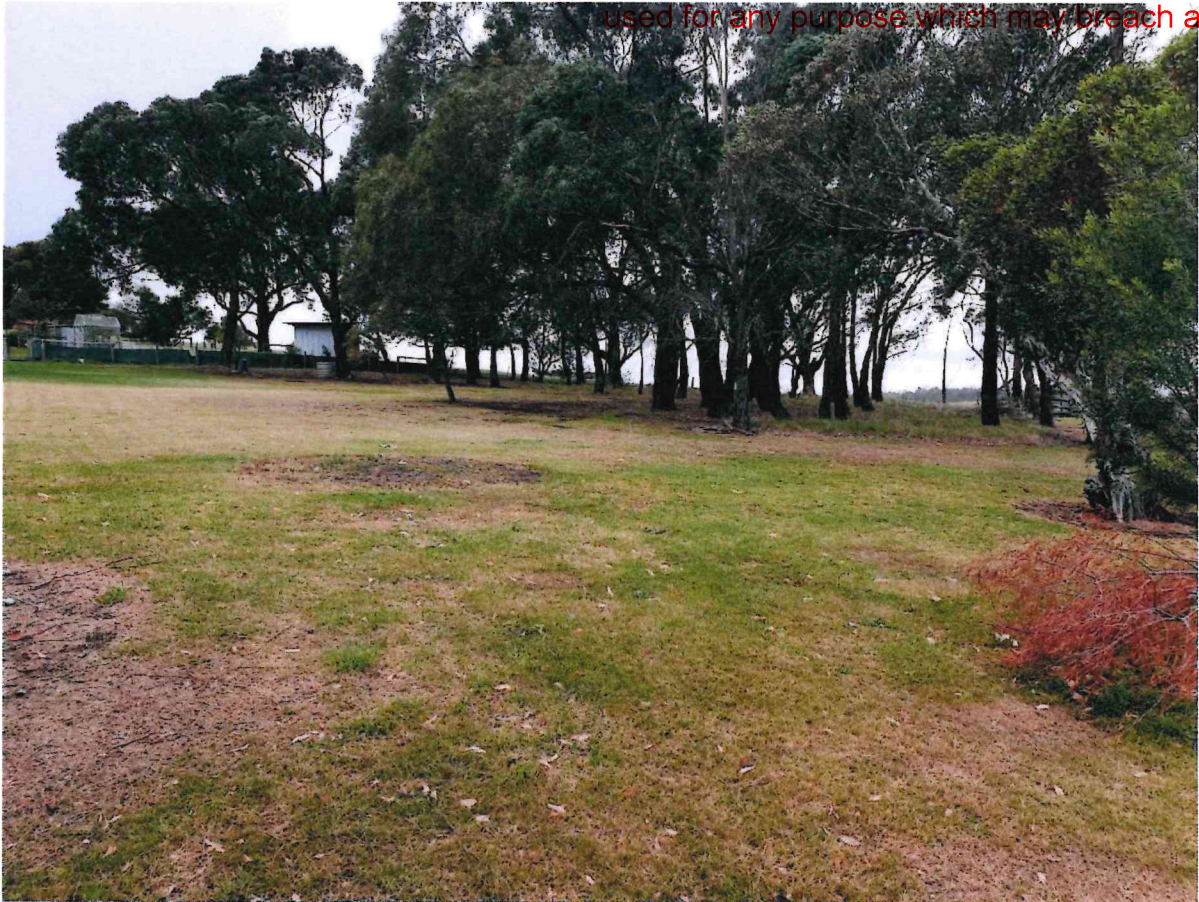
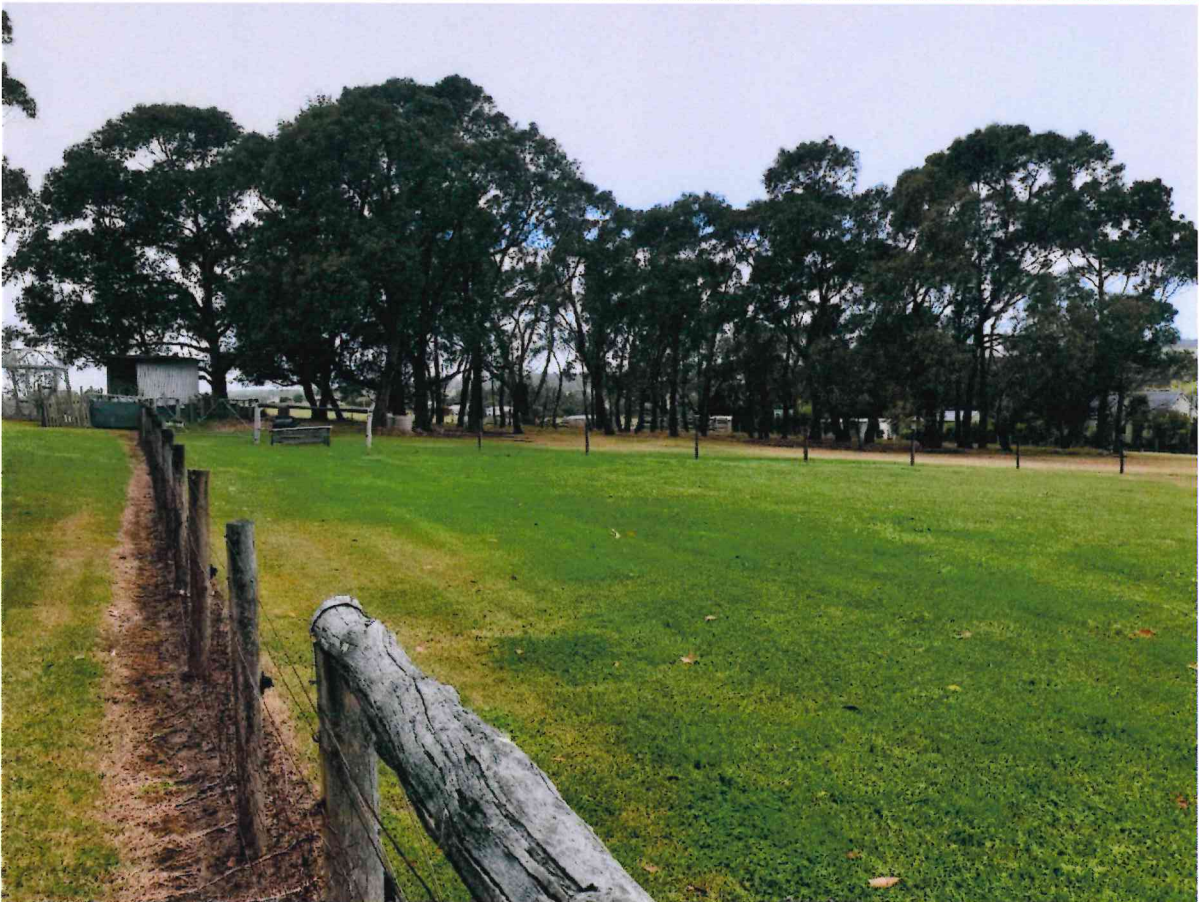
Test Pit 1.

A soil investigation pit was hand excavated at the locations on the attached site plan. The soil at test pit 1 consisted of a moist grey brown silty loam (ZL) topsoil containing coarse grass roots moderately dispersed, underlain by a moist fawn grey brown silty clay loam (ZCL) at 150 – 400mm depth below existing grassed surface, underlain by a moist fawn orange grey fine sandy clay loam (FSCL) to 650mm at termination of test pit.

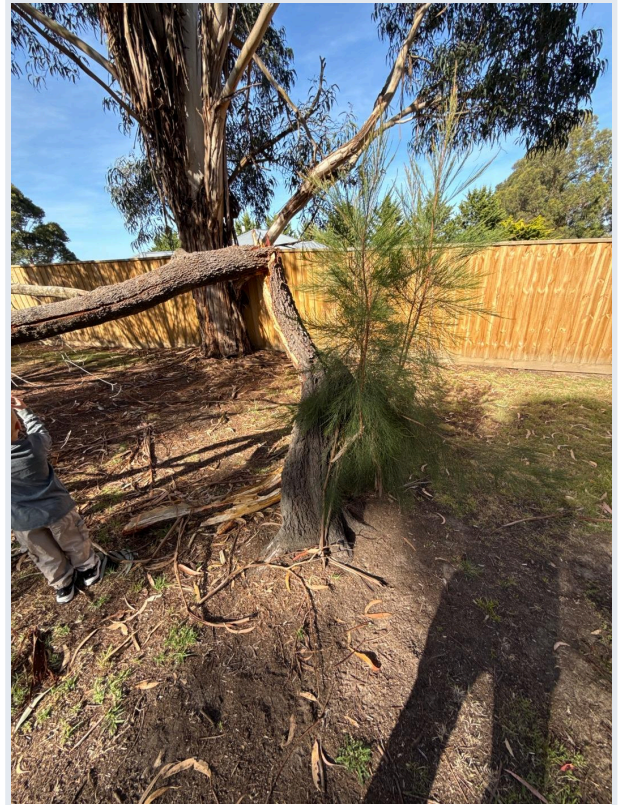
Botanical Name:	Allocausuarina littoralis
Common Name:	Black Sheoak
Genus:	Allocausuarina
Health:	Very Poor
Structure:	Has Failed
Status:	Alive
DSH [cm]:	30
Tree Height (Estimated) [m]:	1
Canopy Spread [m]:	1
Notional Root Zone (NRZ) [m]:	3.6
Structural Root Zone (SRZ) [m]:	2
Useful Life Expectancy:	0 years
Risk Rating:	
Priority of Works:	
Recommended Works:	
Last Modified:	22/04/2026
Observation Comments:	Tree has failed and is within driveway.
Notes:	
Status-Works:

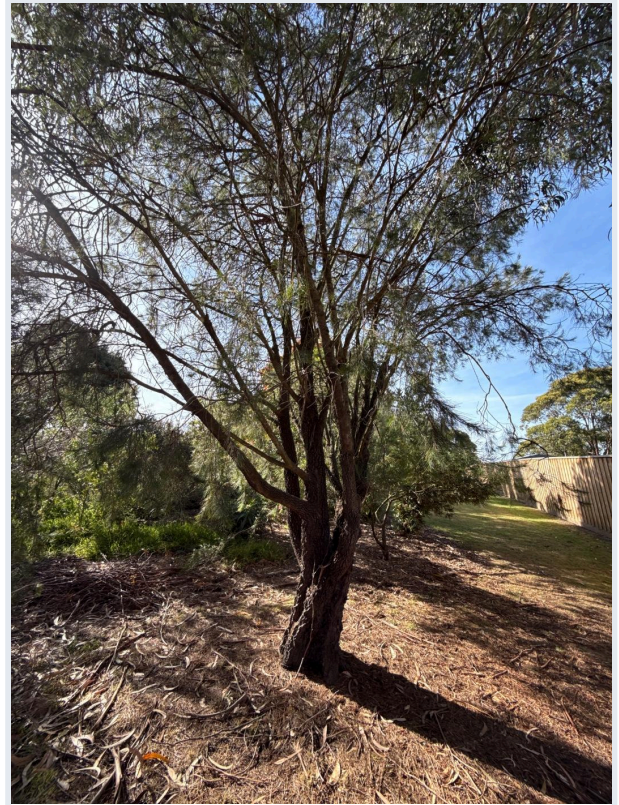
Botanical Name:	Allocausuarina littoralis
Common Name:	Black Sheoak
Genus:	Allocausuarina
Health:	Fair
Structure:	Fair
Status:	Alive
DSH [cm]:	45
Tree Height (Estimated) [m]:	5
Canopy Spread [m]:	3
Notional Root Zone (NRZ) [m]:	5.4
Structural Root Zone (SRZ) [m]:	2.37
Useful Life Expectancy:	11-20 years
Risk Rating:	
Priority of Works:	
Recommended Works:	
Last Modified:	22/04/2026
Observation Comments:	tree is within driveway - removal required
Notes:	
Status-Works:

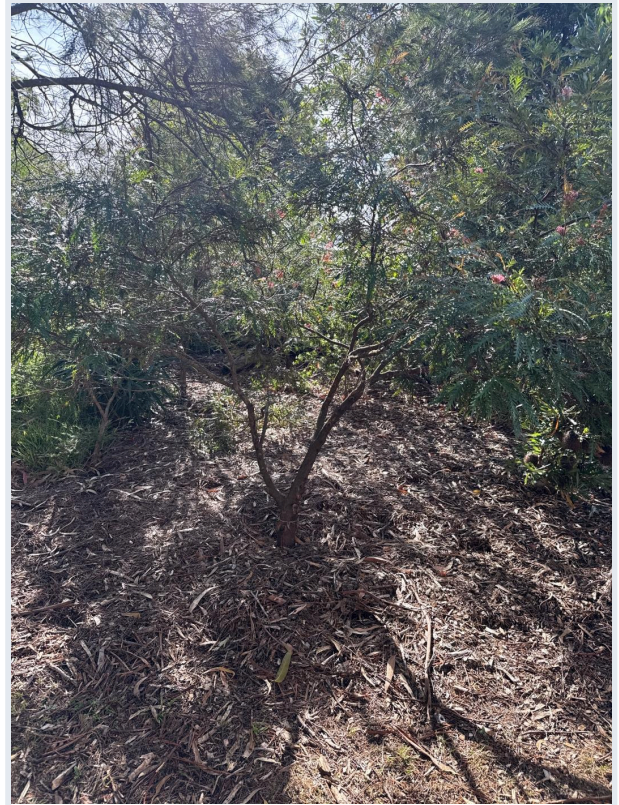
Botanical Name:	Grevillea Longifolia
Common Name:	Fern-leaf Grevillea
Genus:	Grevillea
Health:	Fair
Structure:	Fair
Status:	Alive
DSH [cm]:	5
Tree Height (Estimated) [m]:	2
Canopy Spread [m]:	1
Notional Root Zone (NRZ) [m]:	2
Structural Root Zone (SRZ) [m]:	0.94
Useful Life Expectancy:	1-5 years
Risk Rating:	
Priority of Works:	
Recommended Works:	
Last Modified:	22/04/2026
Observation Comments:	Within driveway construction - remove
Notes:	
Status-Works:

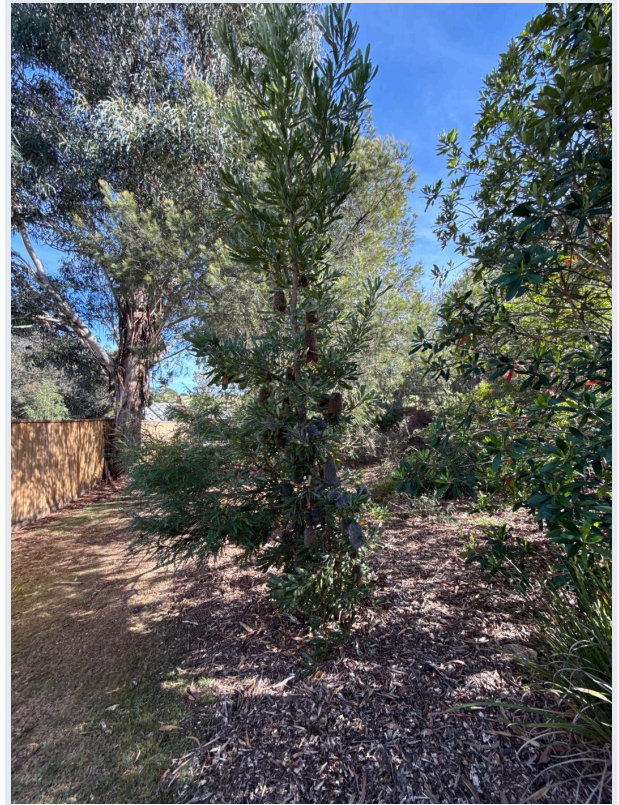
Botanical Name:	Banksia serrata
Common Name:	Saw-tooth Banksia
Genus:	Banksia
Health:	Fair
Structure:	Fair
Status:	Alive
DSH [cm]:	10
Tree Height (Estimated) [m]:	3
Canopy Spread [m]:	1
Notional Root Zone (NRZ) [m]:	2
Structural Root Zone (SRZ) [m]:	1.26
Useful Life Expectancy:	1-5 years
Risk Rating:	
Priority of Works:	
Recommended Works:	
Last Modified:	22/04/2026
Observation Comments:	Within driveway construction - remove
Notes:	
Status-Works:

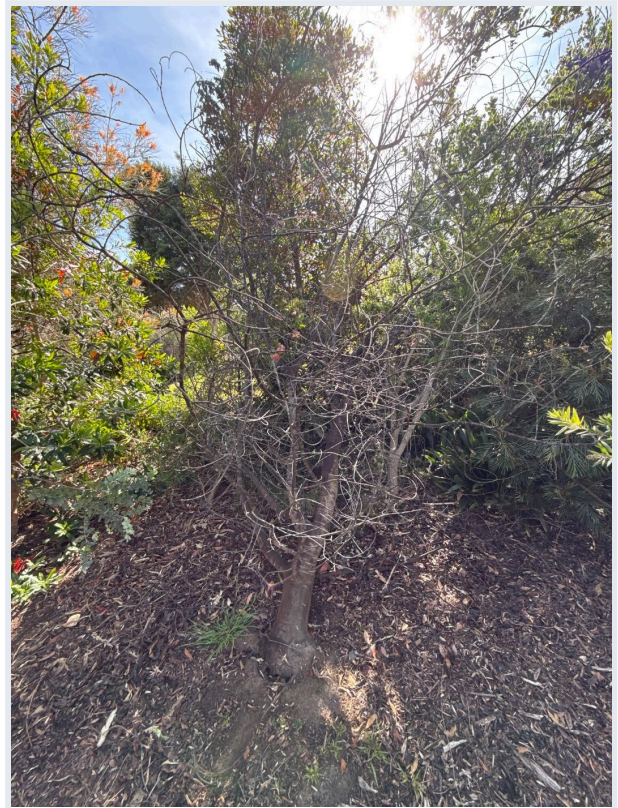
Structure: Has Failed

Observation Comments: tree has failed - tree is outside of driveway construction but removal is still advised

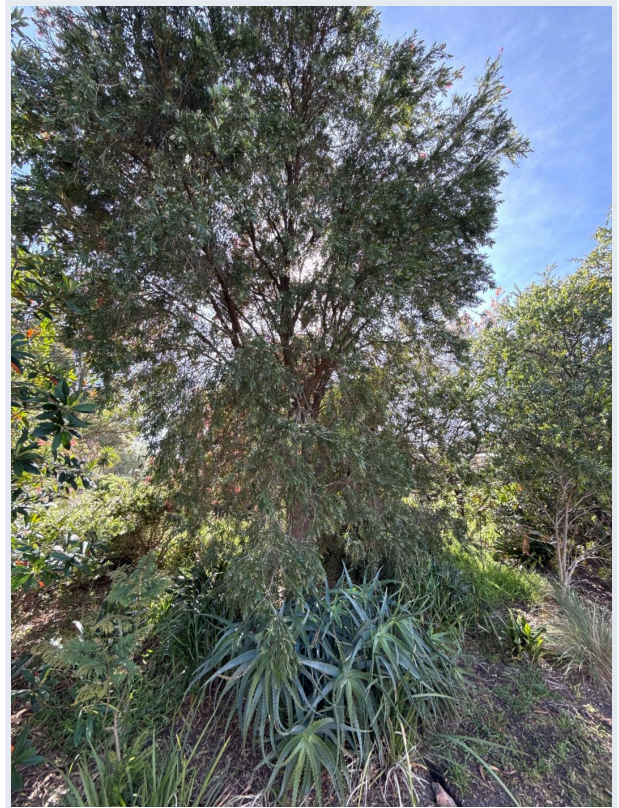
Botanical Name:	Callistemon citrinus
Common Name:	Crimson bottle brush
Genus:	
Health:	Good
Structure:	Good
Status:	Alive
DSH [cm]:	16
Tree Height (Estimated) [m]:	5
Canopy Spread [m]:	2
Notional Root Zone (NRZ) [m]:	2
Structural Root Zone (SRZ) [m]:	1.61
Useful Life Expectancy:	11-20 years
Risk Rating:	
Priority of Works:	
Recommended Works:	
Last Modified:	22/04/2026
Observation Comments:	Tree is within construction area - removal required
Notes:	
Status-Works:

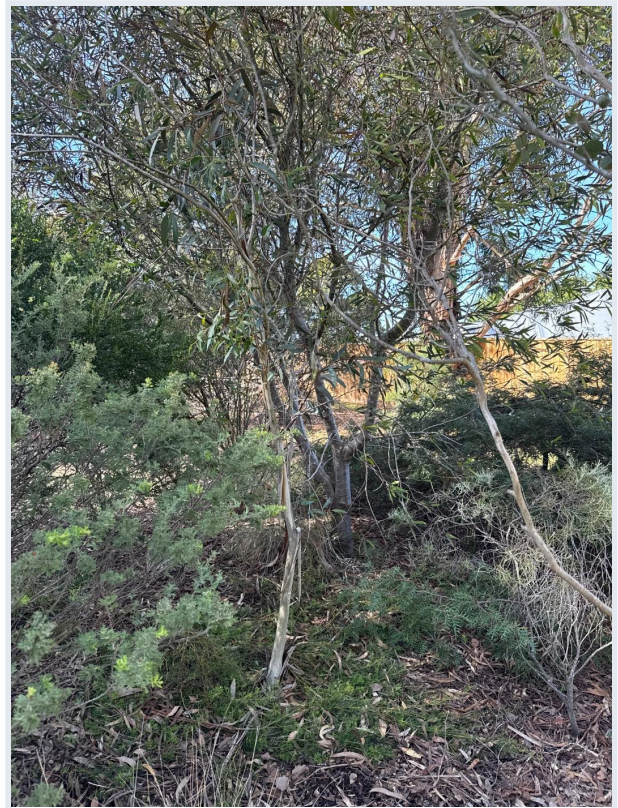
Botanical Name:	Melaleuca sp.
Common Name:	
Genus:	
Health:	Fair
Structure:	Fair
Status:	Alive
DSH [cm]:	5
Tree Height (Estimated) [m]:	4
Canopy Spread [m]:	2
Notional Root Zone (NRZ) [m]:	2
Structural Root Zone (SRZ) [m]:	0.94
Useful Life Expectancy:	6-10 years
Risk Rating:	
Priority of Works:	
Recommended Works:	
Last Modified:	22/04/2026
Observation Comments:	tree is within driveway construction area - removal required
Notes:	
Status-Works:

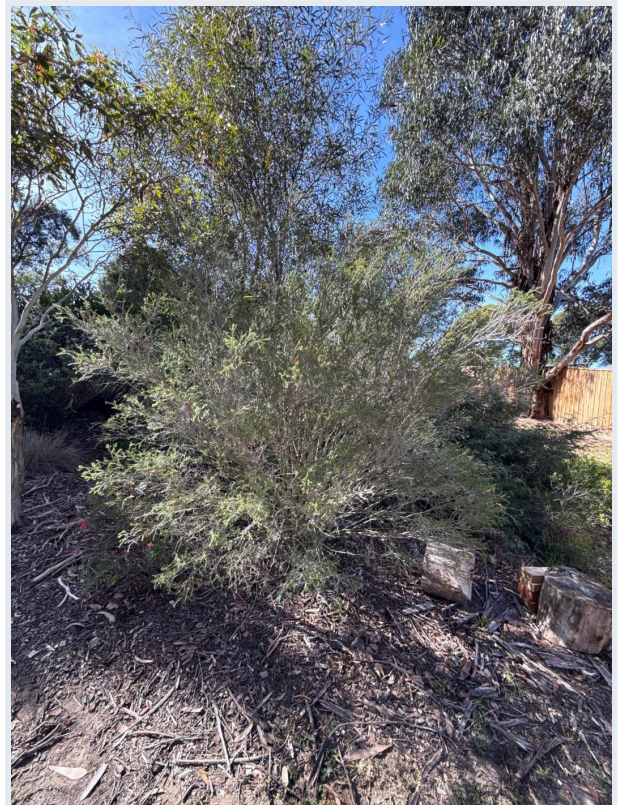
Red silky oak Tree ID #18

Botanical Name:	Grevillea banksii
Common Name:	Red silky oak
Genus:	
Health:	Fair
Structure:	Fair
Status:	Alive
DSH [cm]:	7
Tree Height (Estimated) [m]:	2
Canopy Spread [m]:	3
Notional Root Zone (NRZ) [m]:	2
Structural Root Zone (SRZ) [m]:	1.08
Useful Life Expectancy:	6-10 years
Risk Rating:	
Priority of Works:	
Recommended Works:	
Last Modified:	22/04/2026
Observation Comments:	tree is within driveway construction area - removal required
Notes:	
Status-Works:

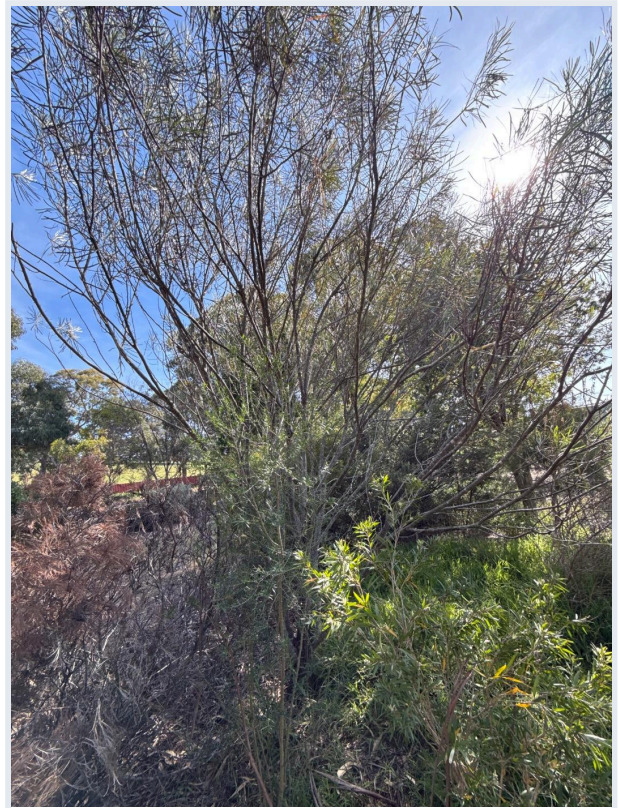
Botanical Name:	Acacia suaveolens
Common Name:	Sweet wattle
Genus:	
Health:	Fair
Structure:	Fair
Status:	Alive
DSH [cm]:	10
Tree Height (Estimated) [m]:	4
Canopy Spread [m]:	3
Notional Root Zone (NRZ) [m]:	2
Structural Root Zone (SRZ) [m]:	1.26
Useful Life Expectancy:	6-10 years
Risk Rating:	
Priority of Works:	
Recommended Works:	
Last Modified:	22/04/2026
Observation Comments:	tree is outside construction area and should be retained
Notes:	
Status-Works:

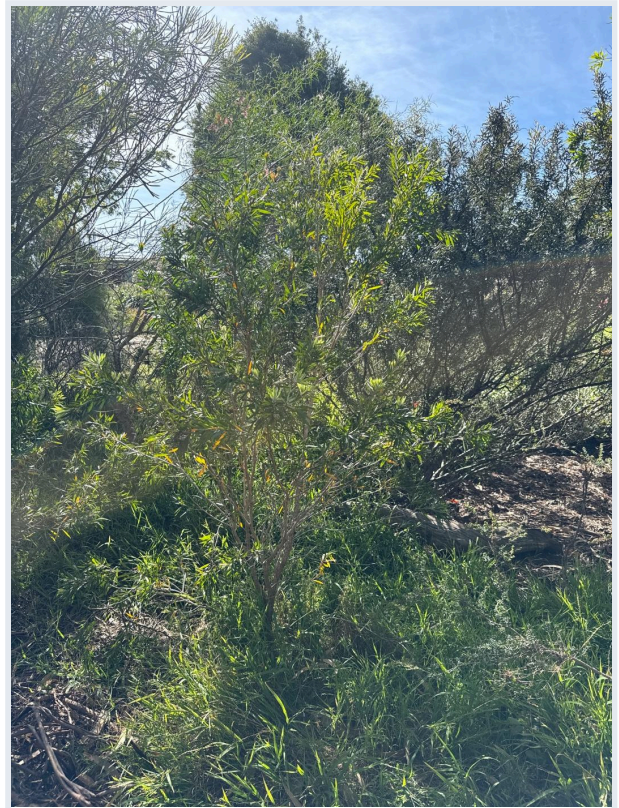
Botanical Name:	Callistemon citrinus
Common Name:	Crimson bottle brush
Genus:	
Health:	Fair
Structure:	Fair
Status:	Alive
DSH [cm]:	10
Tree Height (Estimated) [m]:	2
Canopy Spread [m]:	3
Notional Root Zone (NRZ) [m]:	2
Structural Root Zone (SRZ) [m]:	1.26
Useful Life Expectancy:	6-10 years
Risk Rating:	
Priority of Works:	
Recommended Works:	
Last Modified:	22/04/2026
Observation Comments:	tree is outside construction area and should be retained
Notes:	
Status-Works:
