# East Gippsland Shire Council **Urban Waterway Management Strategy**

## Executive summary

This management strategy reviews the works undertaken by the East Gippsland Shire Council in a number of key reserves and provides guidance on future management opportunities. In addition, the strategy examines the opportunities and constraints in a number of waterway assets that will, after land development, become the responsibility of the Council.

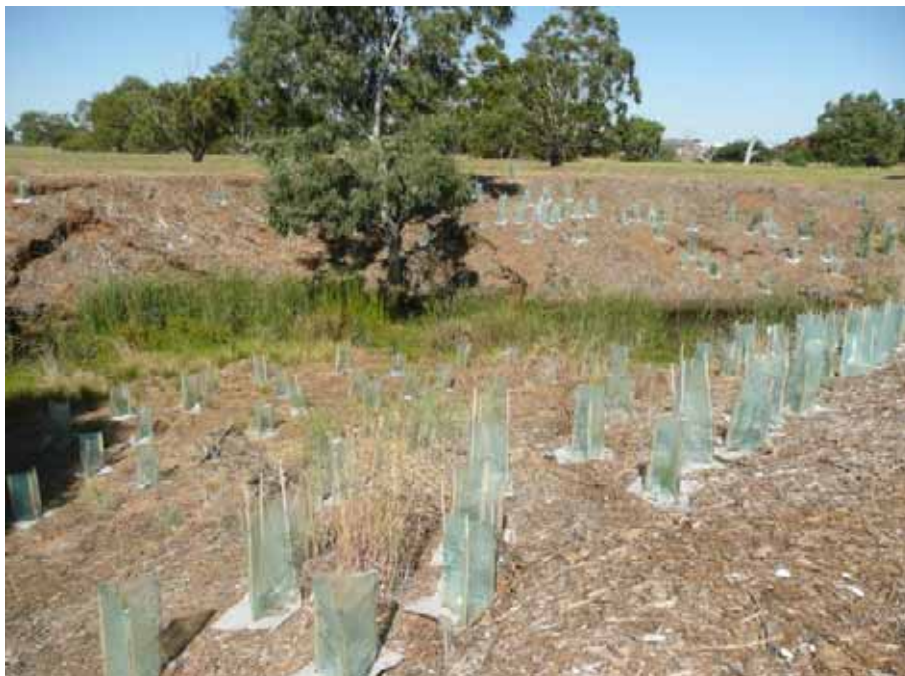
**Figure 4-1    Revegetation works**

Revegetation involves the planting of native vegetation within the riparian zone to re-establish or enhance native vegetation indigenous to the site (Figure 4-1). The riparian zone is defined as the corridor of land that borders a waterway, where the structure, function and composition of the landscape is influenced by the waterway. The native plants established through revegetation must always reflect the species and type of vegetation community suited to the site conditions. The establishment of revegetation may also involve other complementary river health works such as weed control.

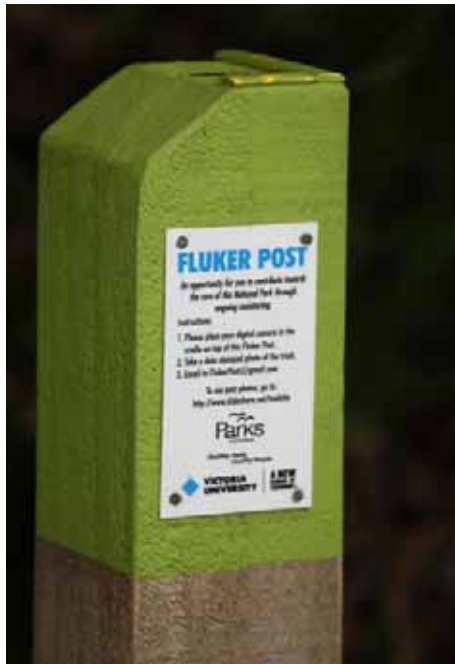
**Figure 4-6 Photo monitoring post installed by Parks Victoria**

A commonly used technique involves the placement of a 90mm x 90mm post concreted into the ground, Parks Victoria have called these a “Fluker Post” (Figure 4-6). The post has a cradle on the top to ensure the exact shot is replicated.

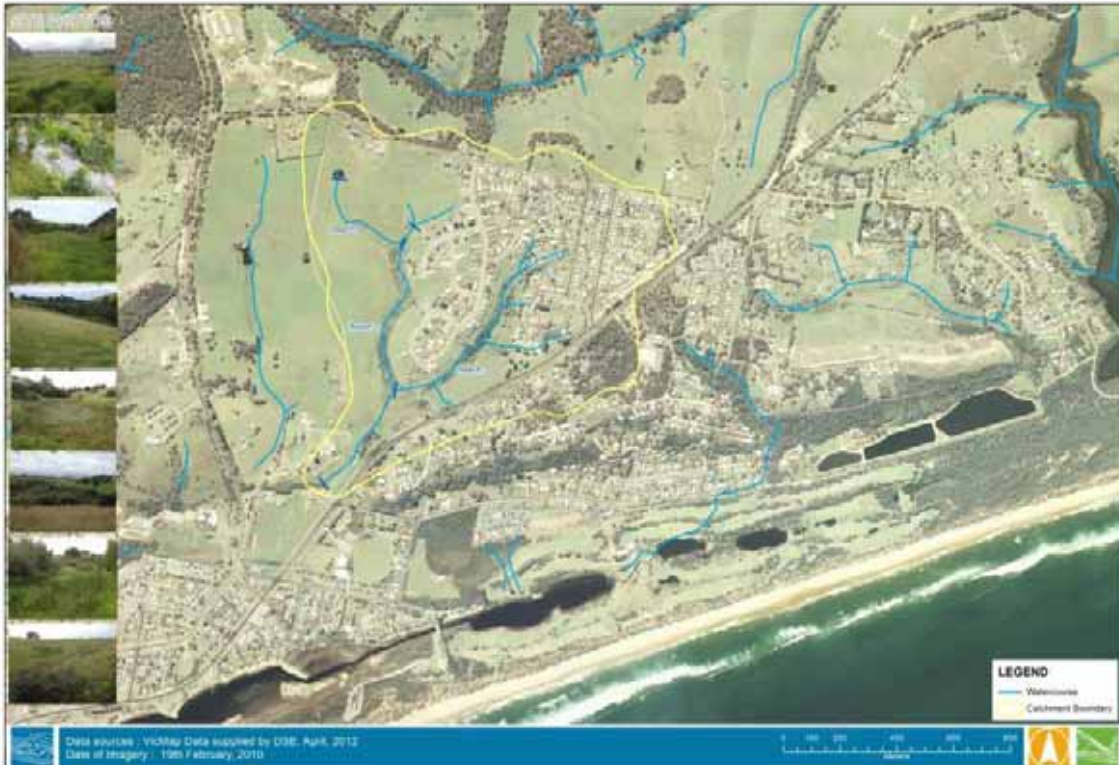
**Figure 5-1 Map of Merrangbaur Heights**

Merrangbaur Heights is a new residential housing development to the north of Lakes Entrance. The development falls almost entirely of the catchment of two tributaries of the unnamed creek (Figure 5-1) that flows from east to west in Lakes Entrance before discharging into the North Arm.

The waterway needs to be split into three distinct reaches to adequately describe the condition (Figure 5-1). The values and condition have been referenced to the policy principles in the 'Policy' document.

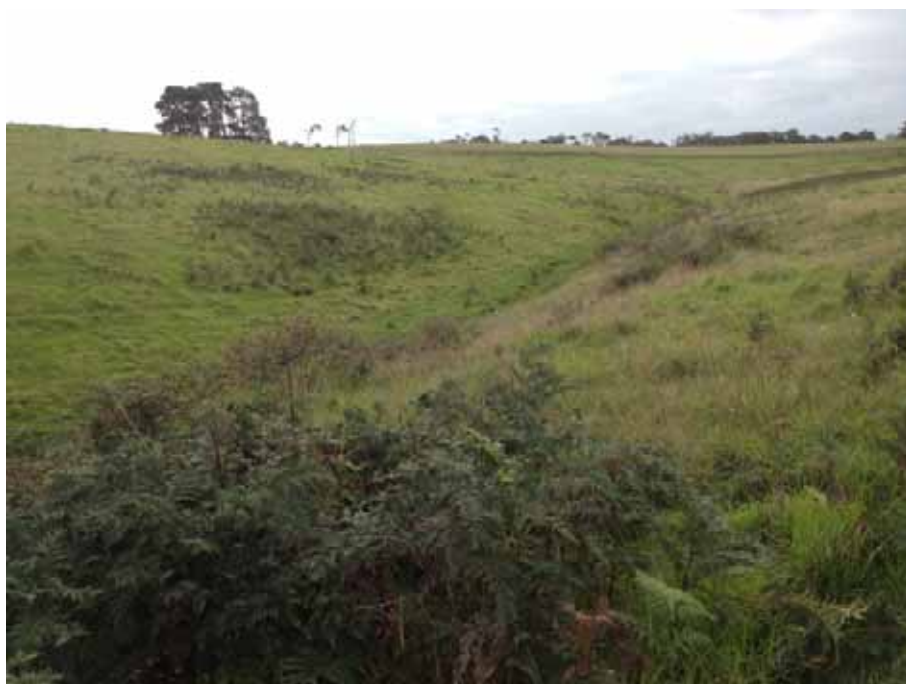
**Figure 5-2**     **Undeveloped or re-vegetated reach of waterway**

The revegetation program has been very successful (Figure 5-2 and Figure 5-3) and is a credit to the council. The diversity of the species and the stable nature of the creek is testament to the works that have been undertaken.

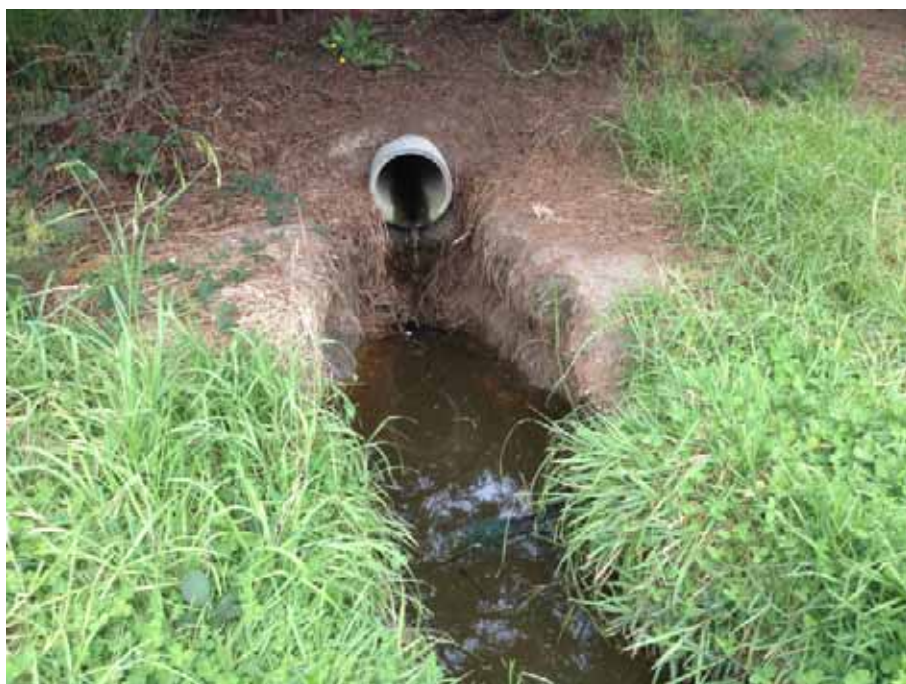
The direct discharge of stormwater to the creek has caused a few minor erosion issues at the points of discharge to the creek (Figure 5-4). Whilst this is not of a major concern at this stage there is a benefit to monitoring the situation and possibly retro-fitting the outlets with sediment basins where access is available.

**Figure 5-4 Direct discharge to the creek of stormwater without adequate headwall protection**

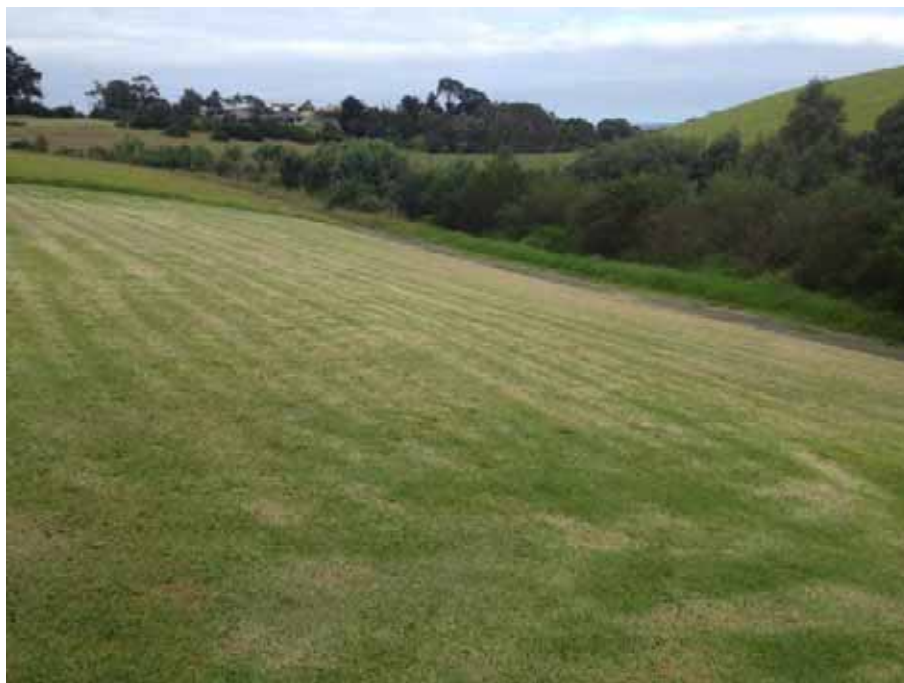
**Figure 5-5 Managing the area between the riparian corridor and the houses**

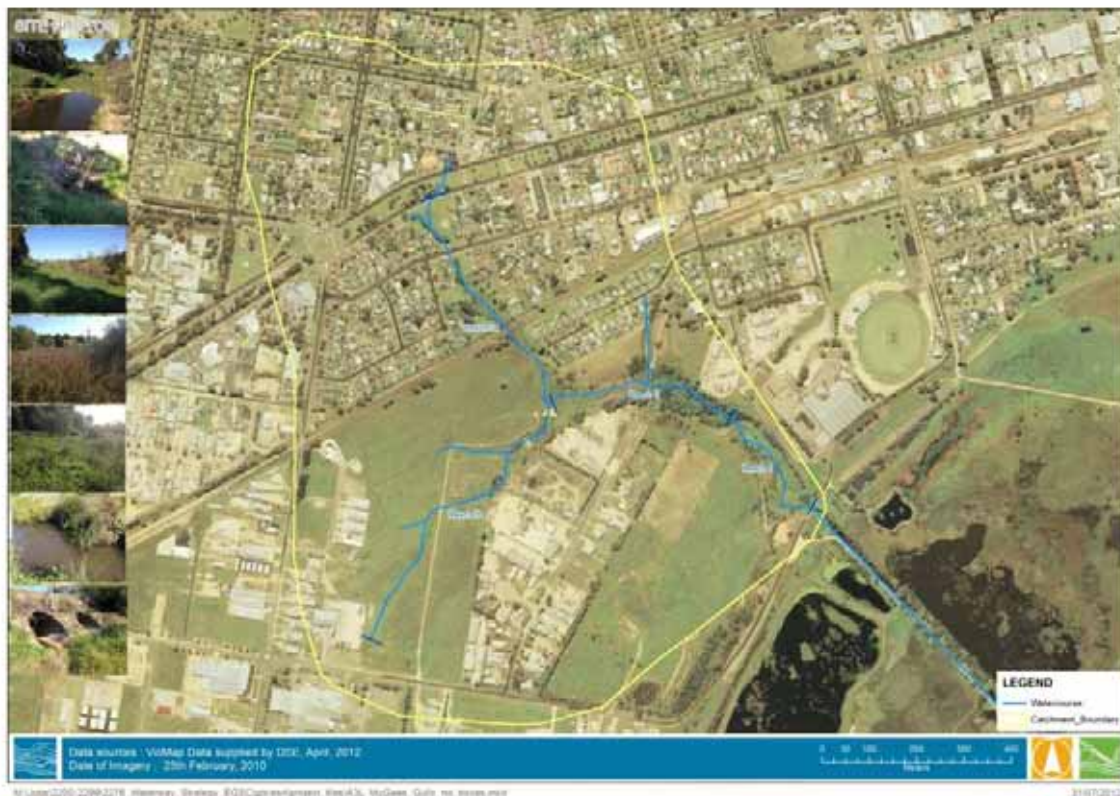
**Figure 5-6 Map of Magees Gully**

The top of the catchment is to the north of the Bairnsdale West Primary School (Figure 5-6) and takes in the industrial precinct bounded by Bairnsdale Forge Creek Road and Bosworth Road.

The piped stormwater network discharges into the top of the creek at the Princes Highway, is again piped under Macleod Street and then remains in an open channel through to the Macleod Morass. The southern tributary is an ill-defined channel from Bosworth Road to the creek opposite Dalmahoy Street. A gross pollutant trap has been installed by council at the Princes Highway.

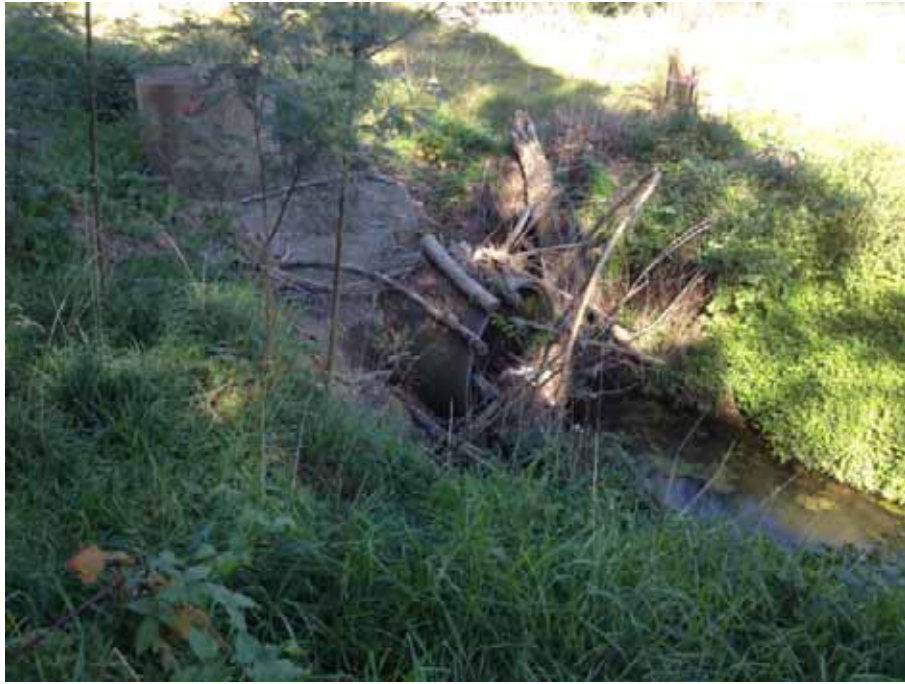
**Figure 5-7 Stormwater pipe inlet/barrier**

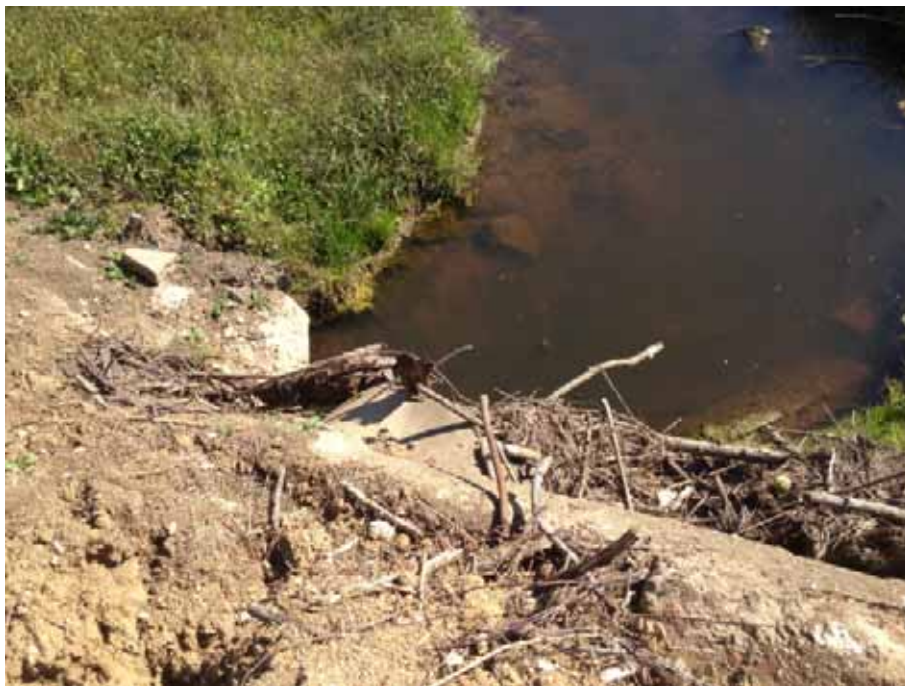
**Figure 5-8 Temporary crossing barrier**

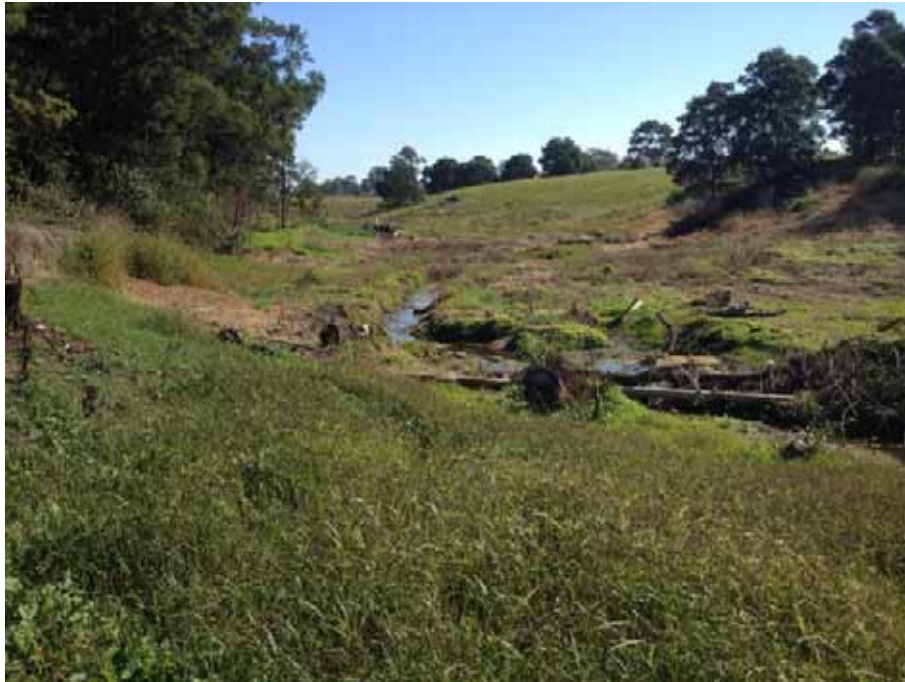
**Figure 5-9 Recently cleared area awaiting revegetation**

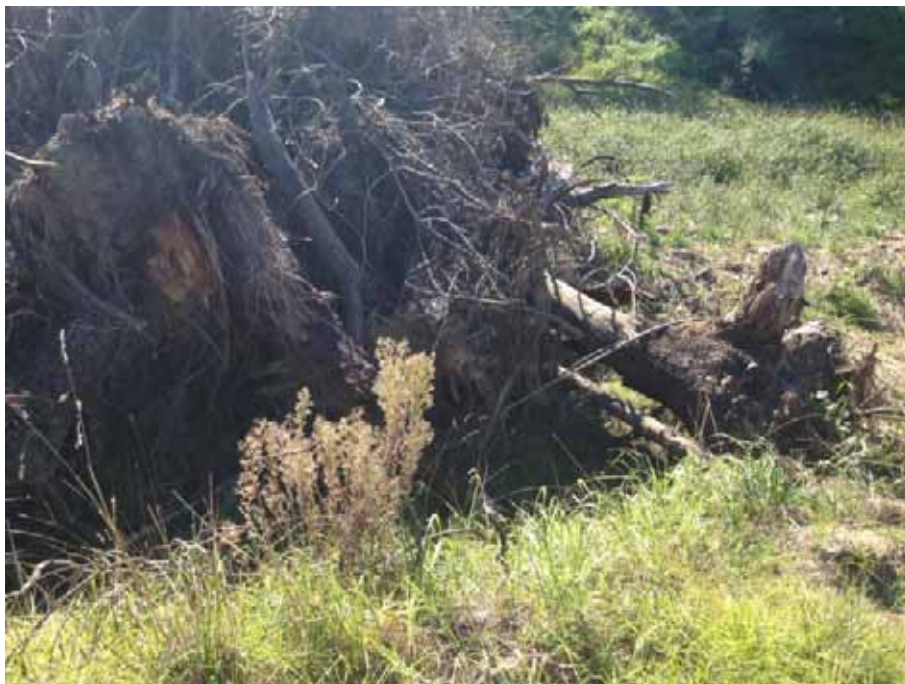
**Figure 5-10 Native LWD has been cleared with the willows**

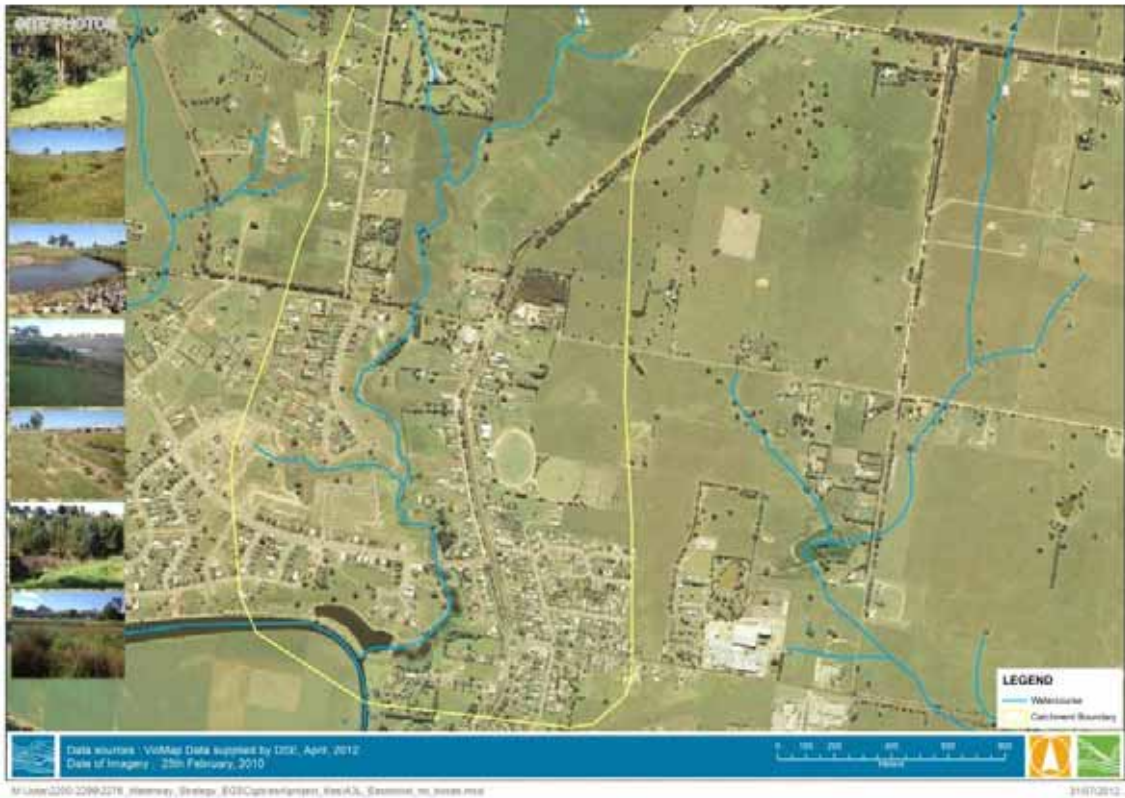
**Figure 5-12 Developed area of Goose Gully**

Goose Gully is a tributary of the Mitchell River in Lucknow, north of Bairnsdale (Figure 5-11). The focus of this investigation is the area in Council management south of Eastwood Road (Figure 5-12), actions however will consider the whole catchment.

Goose Gully has been the site of significant land development over the past 10+ years. The residential land release adjoining the creek has incorporated landscaping and waterway improvement works. These works have included re-vegetation, stabilisation, social infrastructure and end of line wetland works.

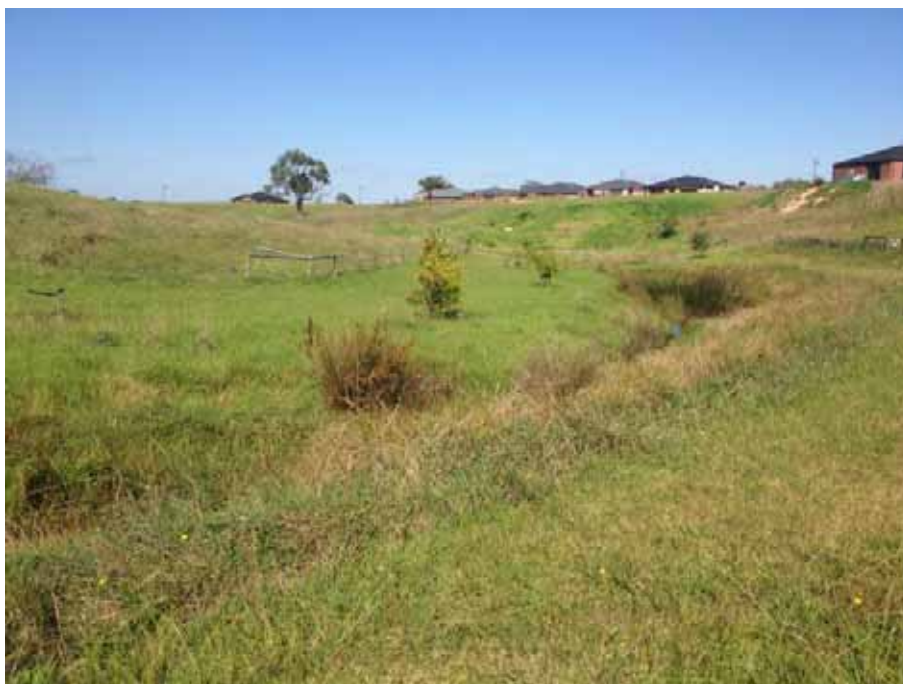
Due to the topography of the land development there are wide corridors adjoining the creek. The landscaping works within the development have been primarily focussed on the creation of open space and there are areas that have been planted with exotic deciduous species (Figure 5-13).

**Figure 5-13 Sparse open space with exotic tree species**

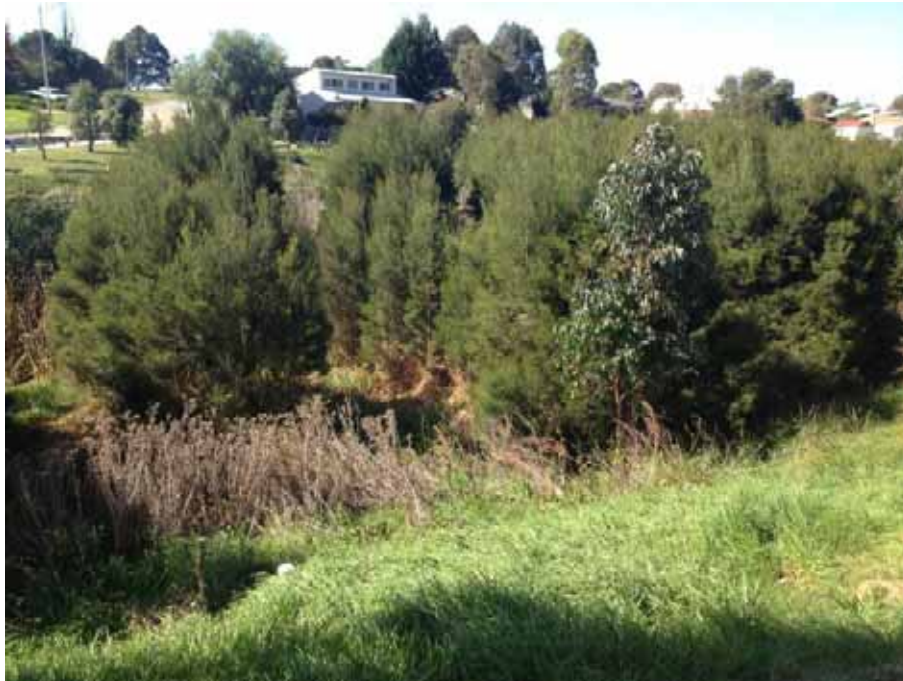
The reach from just above Flinns Road to the connection with Blackwater River, adjoining the Mitchell River, has a lesser gradient and a wide poorly defined channel. The vegetation is dominated by *Phragmites* upstream of the road, indicating a pooling of water, and densely planted *Melaleuca* forest downstream creating a very stable shallow and wide channel (Figure 5-14).

**Figure 5-14 Dense Melaleuca planting across the channel**

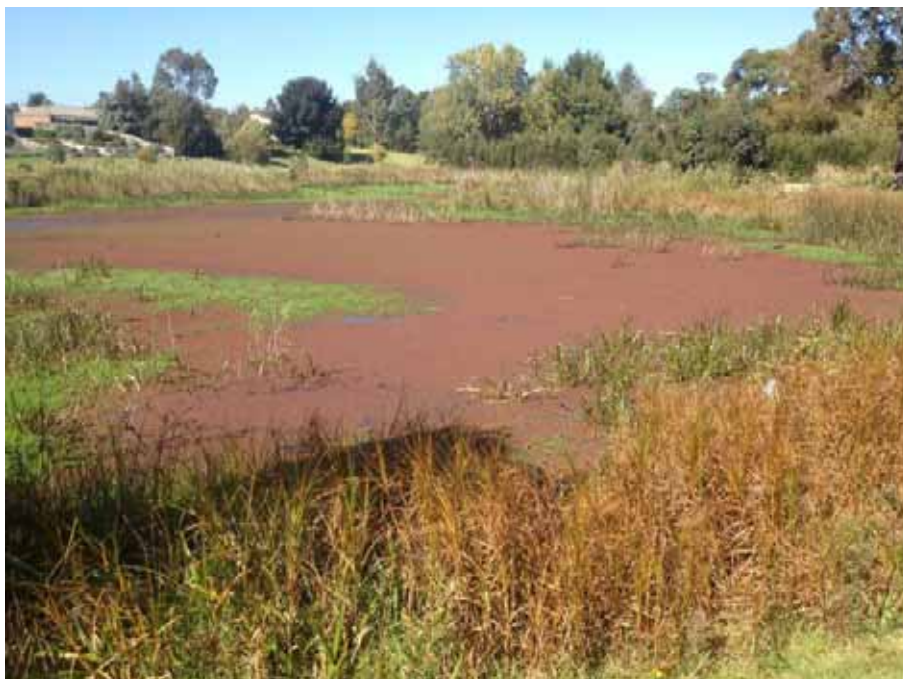
The remaining channel has been modified to encompass a constructed wetland and lake (Figure 5-15).

### **Figure 5-15 Constructed wetland lake**

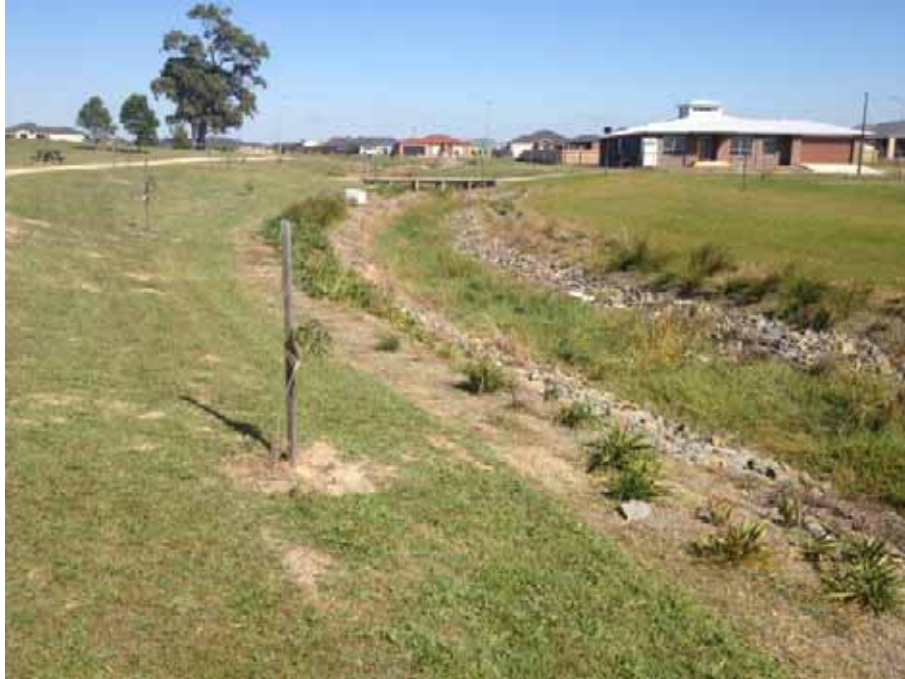
The western tributary in the development is a formed drainage line with a trapezoid form (Figure 5-16) and occasional ponds. This tributary has a large on-line retarding basin on it prior to discharging to the main channel, Figure 5-17.

**Figure 5-16 Stable formal drainage lines**

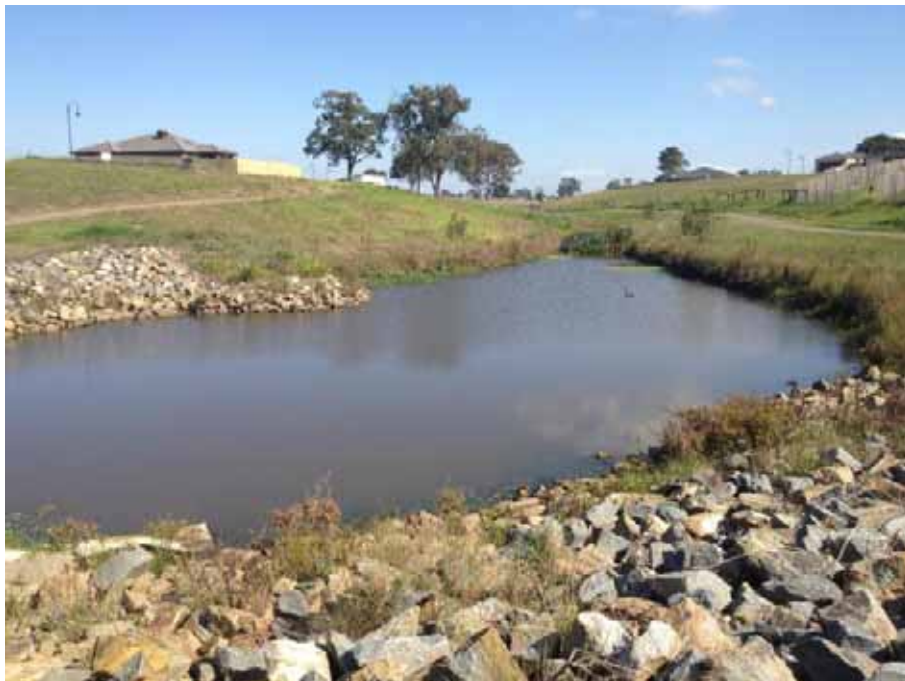
**Figure 5-17 On-line retarding basin**

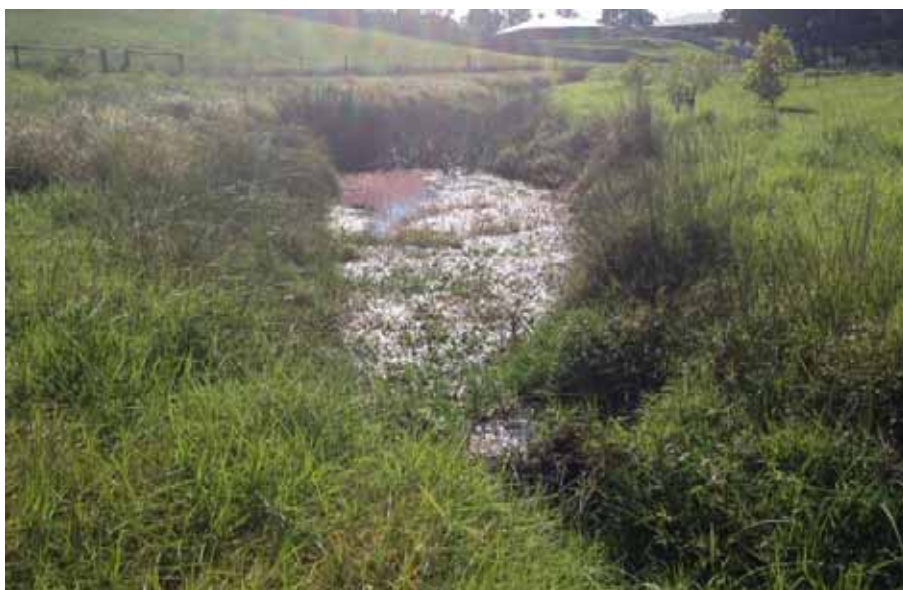
**Figure 5-18 Valuable habitat pools with some good fringing emergent macrophyte vegetation**

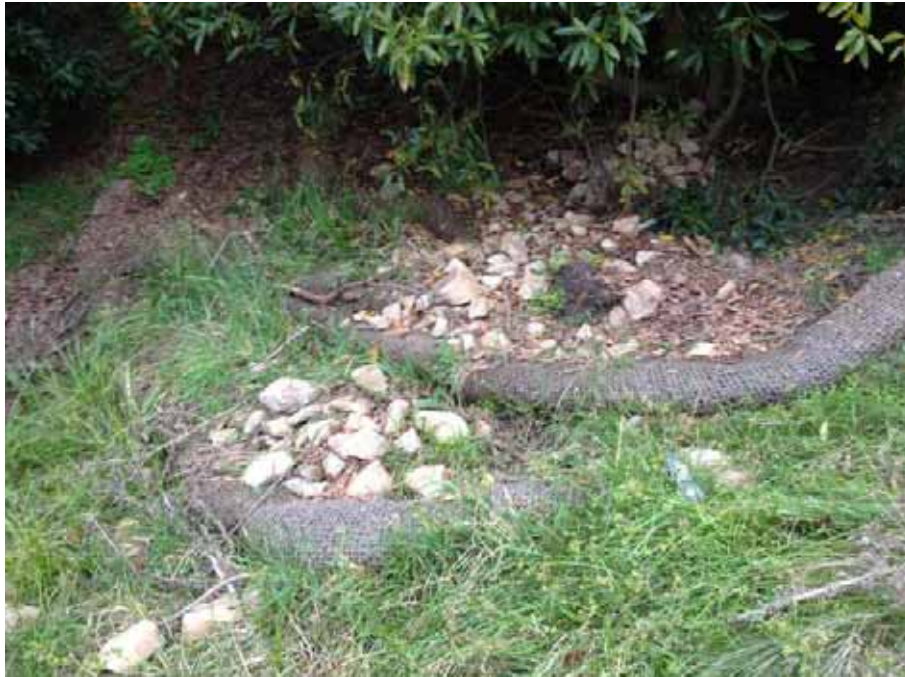
**Figure 5-20** Stabilisation works with 'Eco-logs'

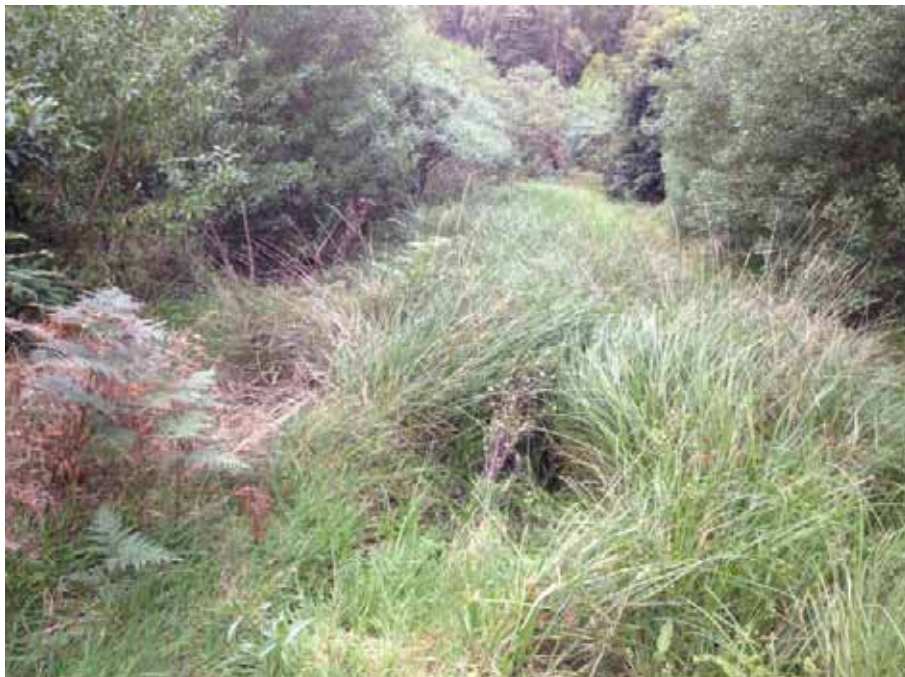
**Figure 5-21** Re-vegetated down waterway reach

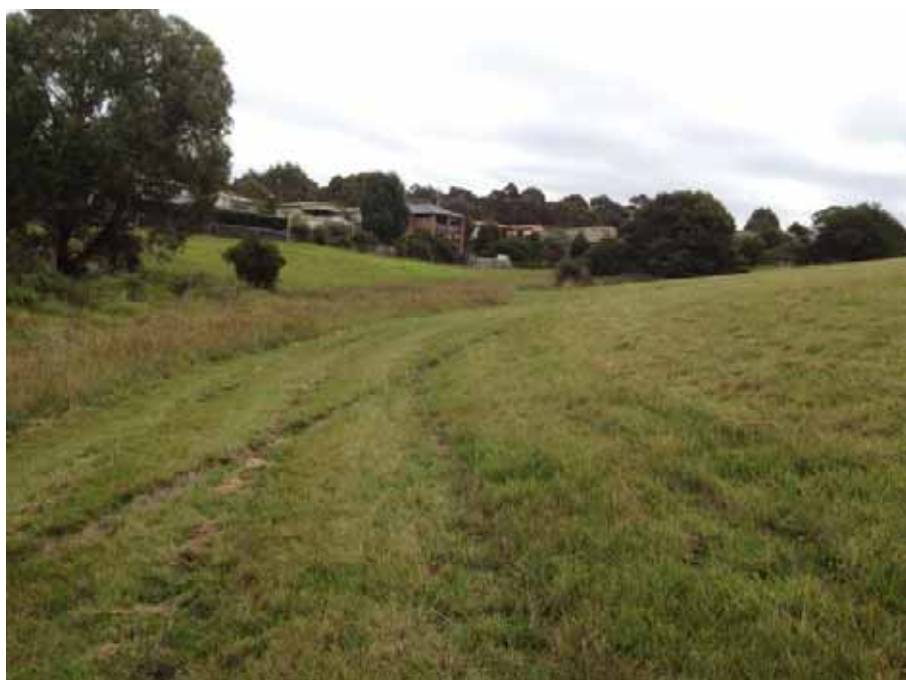
Reach 2, the upper section of the creek (Figure 5-22), has a defined channel with bed and banks. The channel is stable and overlies a silty soil substrate and there is a ford footpath crossing over the channel. The density of the introduced grasses in the channel are serving

to reduce the velocity of any flows, trap sediment and maintain a stable channel. There are few defined channel features that would provide any significant habitat.

**Figure 5-22 Up waterway Reach**

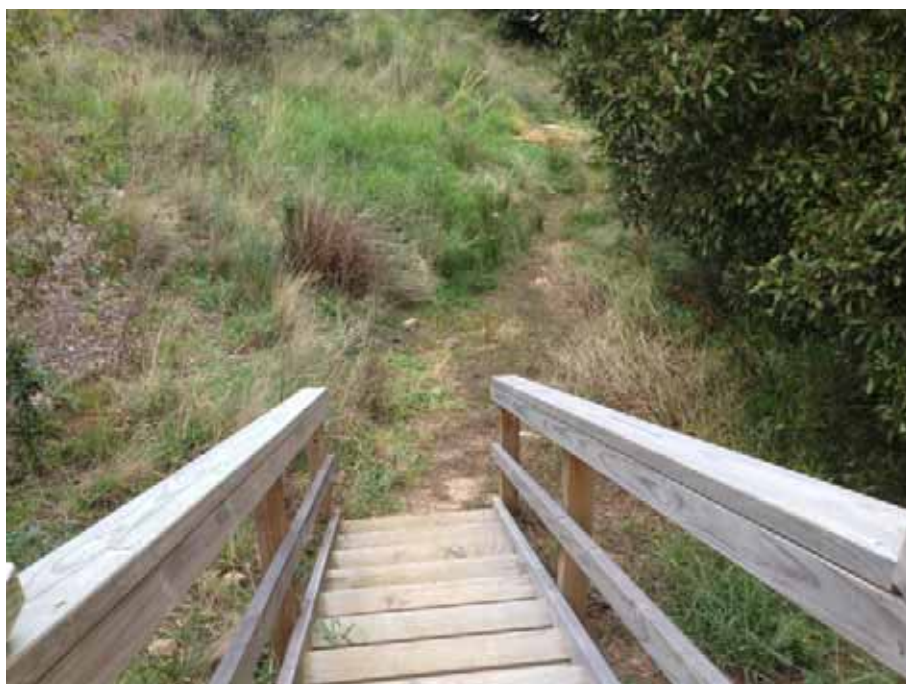
**Figure 5-23 Formal access way into the gully**

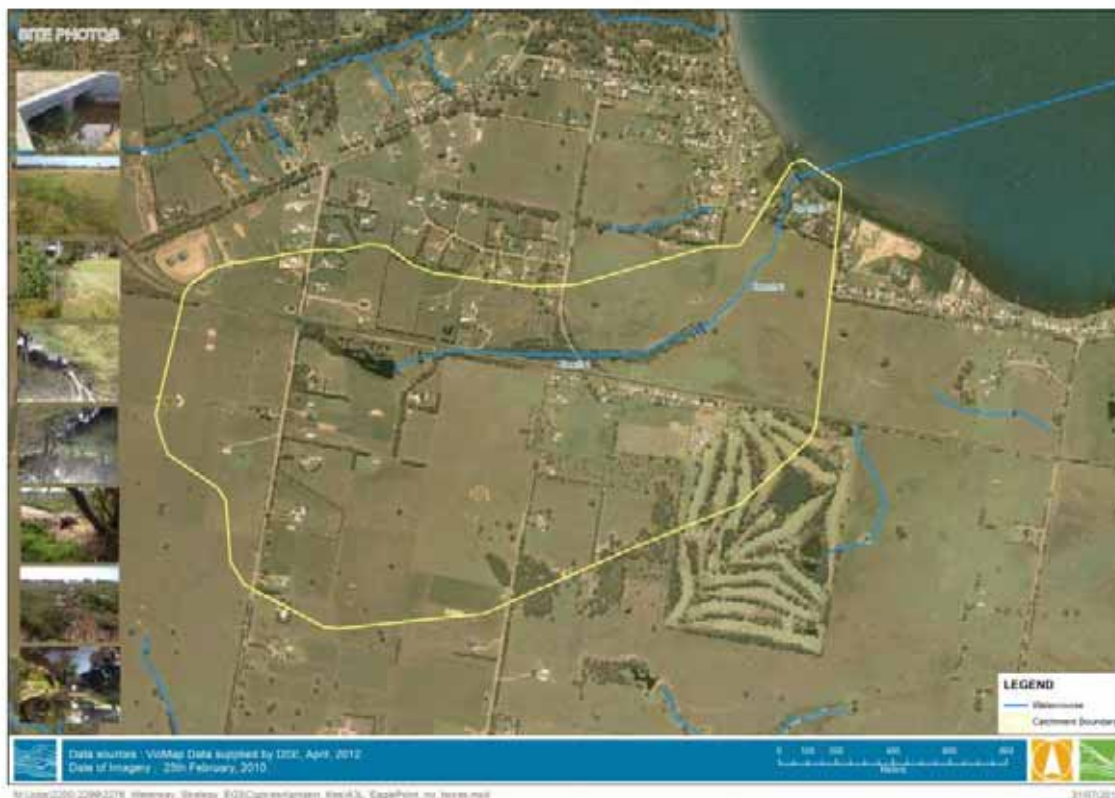
**Figure 5-24 Eagle Point location map and catchment**

The Creek at Eagle Point is a 1.8km un-named tributary that flows directly to Lake King (Figure 5-24). The catchment is currently dominated by grazing land and rural residential. Land releases are underway in the north of the catchment which have the potential to significantly alter the hydrology of the creek. There are half a dozen houses adjoining the creek where it discharges to Lake King.

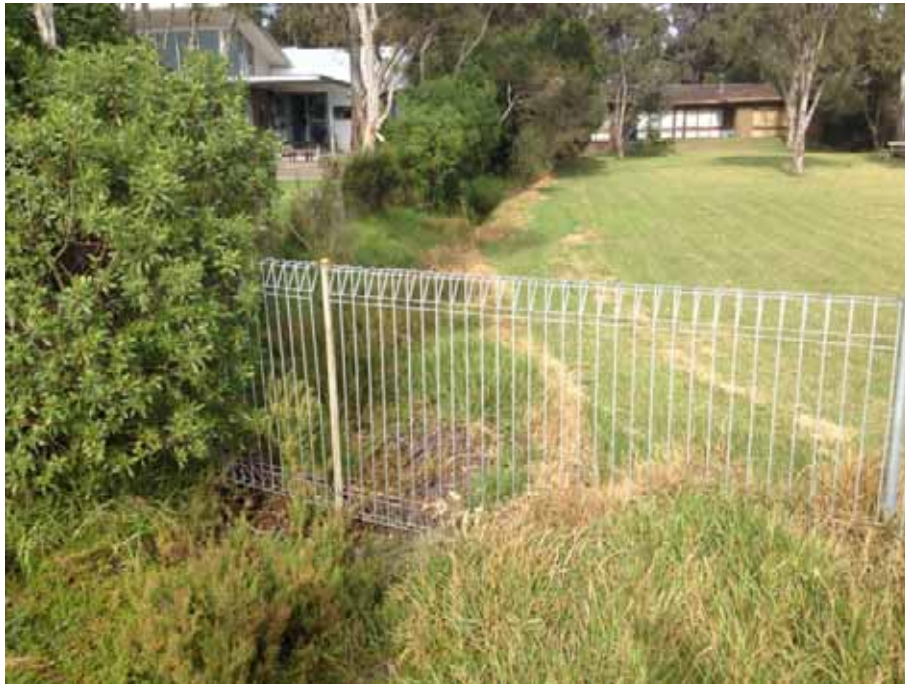
**Figure 5-25 Creek adjoining beach**

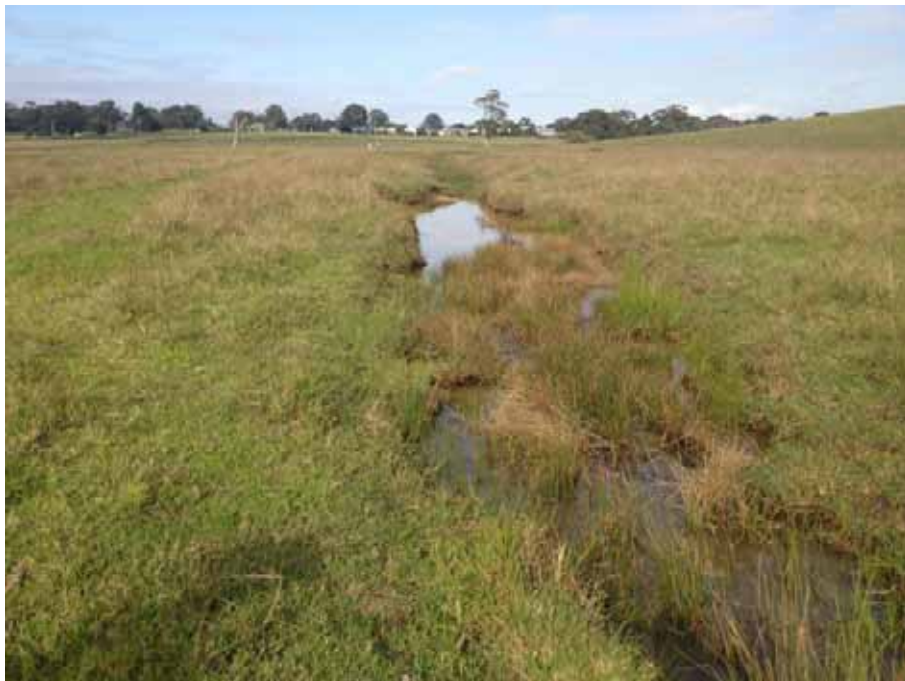
**Figure 5-26 Cleared reach of creek subject to grazing**

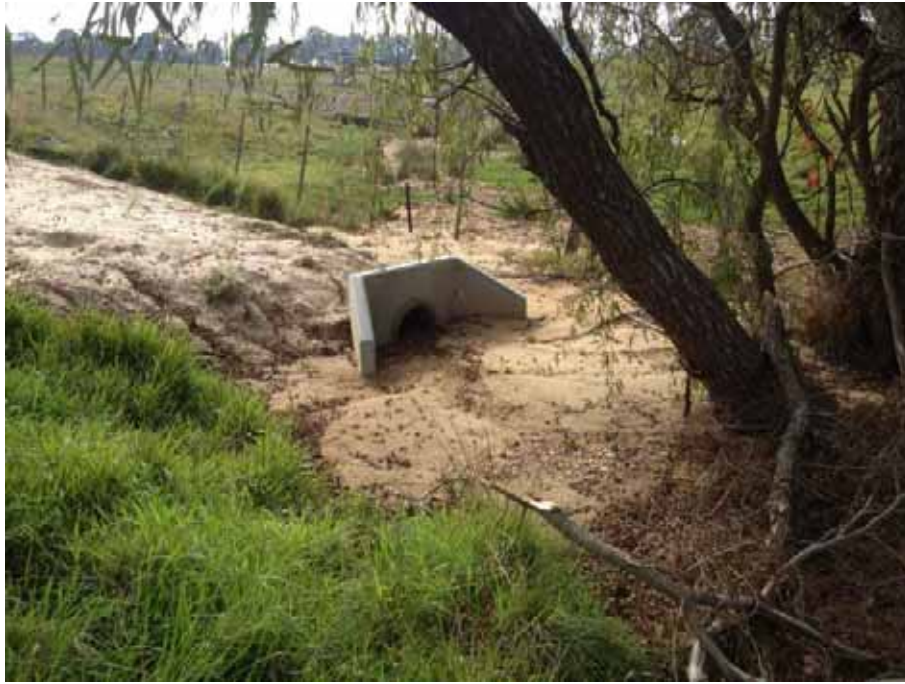
pronounced sand slug adjoining the development that is currently under construction (Figure 5-27).

**Figure 5-27 Sediment from land development is a major threat to this creek**

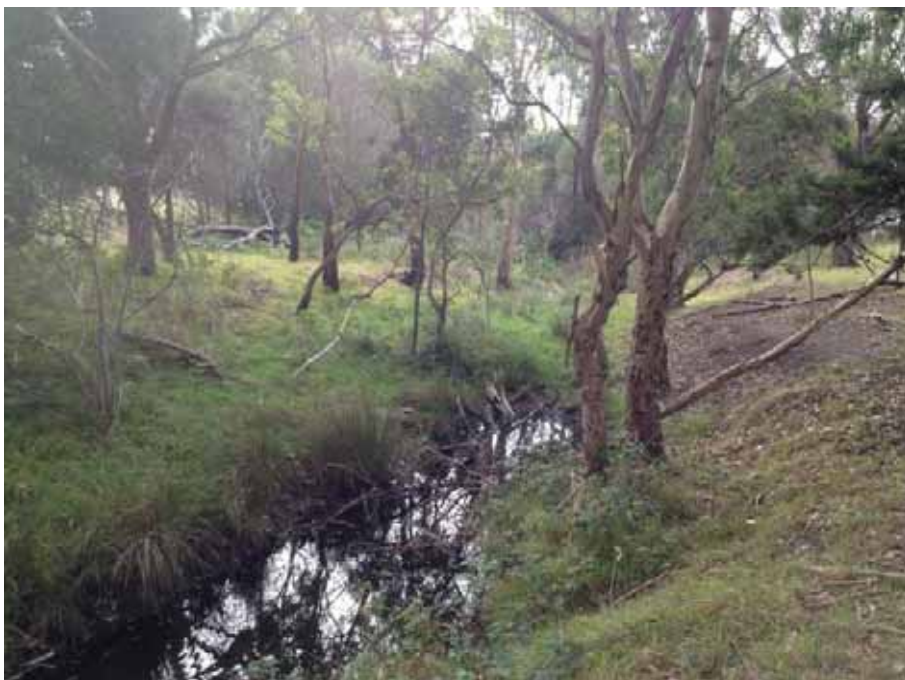
**Figure 5-28 Vegetated channel with high habitat values in-waterway and on bank**

The upper vegetated reach 3 is incised into a gully and has a pool riffle sequence (Figure 5-28). The pools appear to be permanent and provide high value habitat. During the site investigation native fish were observed. An on-line dam/sediment basin had been constructed within the upper reach 3.
